### **EXISTING MECHANICAL CONDITIONS SUMMARY**

The items listed below are based on our site visit on Nov 10, 2016. Our review is based on current conditions and anticipated future use of these building. In the context of current mechanical code references, we used 2009 International Energy Code (IECC). NFPA31, 90A, 90B and 96 are also referenced where applicable. Minimum required ventilation requirements are from the 2009 International Mechanical Code.

Annex

Library

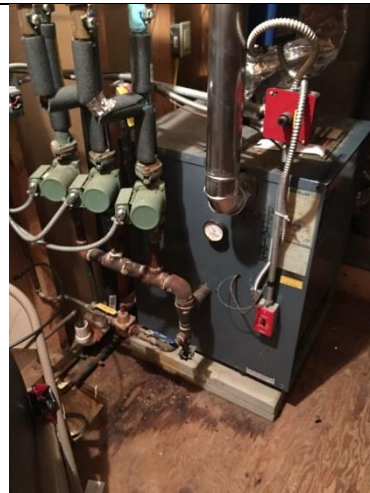
Heating system is hydronic (hot water) baseboard with finned tube radiation around the perimeter. Boiler is standard efficiency propane fired boiler located on the second floor. There are three zones – two on the first floor one on the second, zoning is by pumps. There is no mechanical ventilation in the building. The bathroom does have an exhaust fan that appears to be operational.

Boiler with zone pumps

Replace boiler with propane condensing high efficiency unit. New boiler can be located in the same location as the existing boiler.

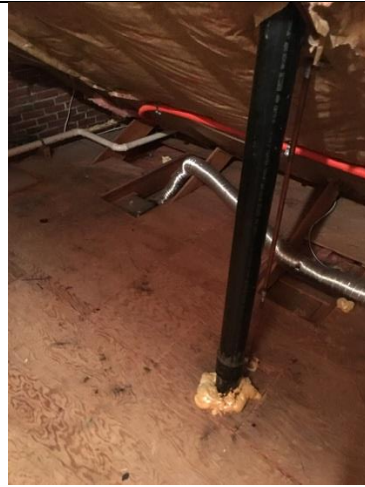
Exhaust ductwork from bathroom exhaust fan

Replace exhaust fan in all bathroom as a minimum.

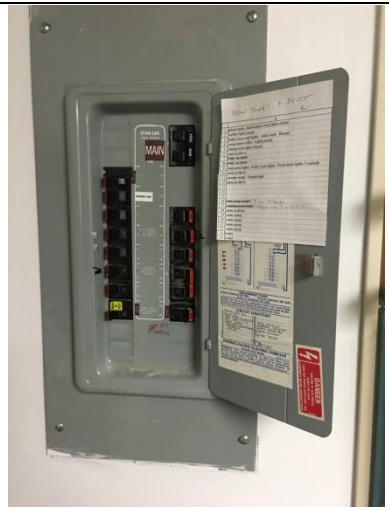
Power Distribution: The electrical service that serves the building is overhead from a pole mounted transformer 120/240V single phase 100A main breaker panel located in the storage room. Utility meter is located at side of the building. Much of the wiring and electrical distribution equipment (panel) in the building has exceeded its service life and is in poor condition. All electrical wiring in the building should be replaced.

Existing Federal Pacific panel

Replace panel

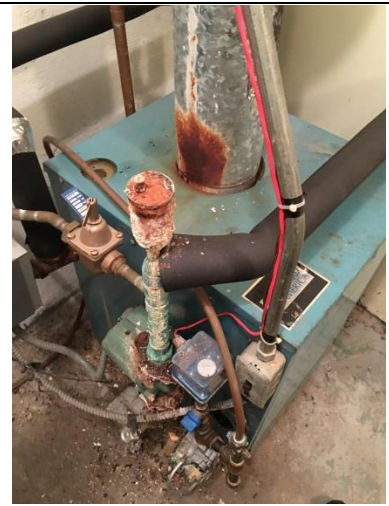
Heating system is hydronic (hot water) baseboard with finned tube radiation around the perimeter. Boiler is standard efficiency propane fired boiler. There is no mechanical ventilation in the building. The bathroom does have an exhaust fan that appears to be operational.

Burnham Boiler

Replace boiler with propane condensing high efficiency unit. New boiler can be located in the same location as the existing boiler.

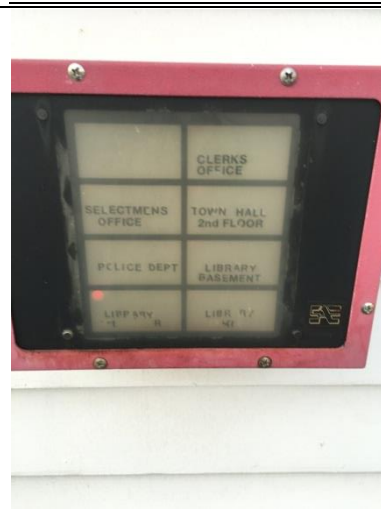
**Fire Alarm System:** There is a fire alarm system in the building the fire alarm panel is located in the storage room. Fire alarm system consists of Silent knight 5207 panel that serves the site (including Annex, Town Hall and Library) and there is an exterior annunciator used for fire department response on this building. There are horn/strobes located throughout the facility but does not comply with current NFPA and ADA codes. Additional devices need to be added to bring the system up to current NFPA and ADA codes.

Fire alarm annunciator

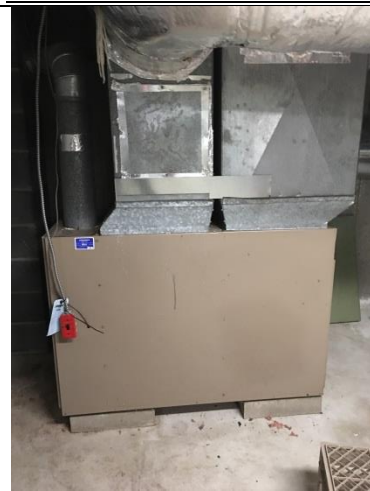
Heating system is propane fired furnaces ducted into the areas. One standard efficiency furnace serves the majority of the building that has an associated AC unit ducted into the basement that is changed over in summer. There is a newly installed high efficiency unit located in the most recent addition in the basement children's area. Neither system provides mechanical ventilation in the building. The bathroom does have an exhaust fan that appears to be operational.

Standard Efficiency Furnace – original portion of the building

Replace one furnace with propane condensing high efficiency unit. New unit can be located in the same location as the existing furnace.

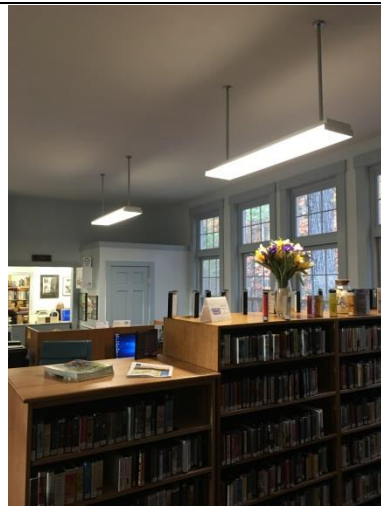
General Lighting: The lighting is a combination of T12 fluorescent. The majority of the lighting could be upgraded to more energy efficient LED type. These types of fixtures will save on re-lamping costs and energy usage costs.

Lighting original portion

Install new LED lighting.

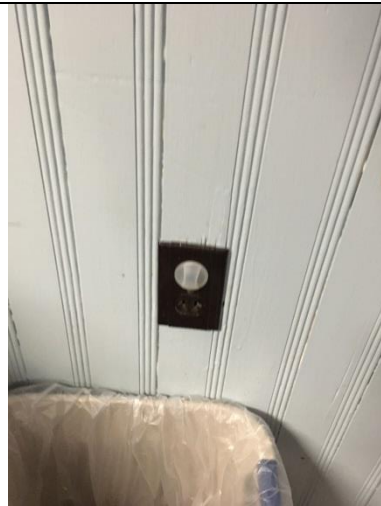
Standard ungrounded outlet

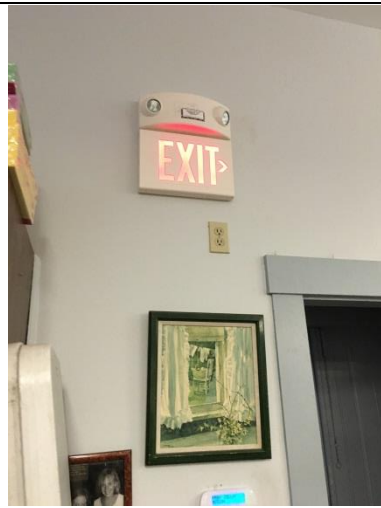
**Exit and Egress Lighting:** There are emergency lights in the building. There are exit signs at the main exits but more are needed to comply with current codes. Emergency battery lighting needs to be added to the facility to meet NFPA 101 Life Safety Code on the interior and exterior. Existing exit signs should be replaced and supplemented to meet NFPA 101 Life Safety Code.

Exit and emergency lighting

Install code required emergency and exit signs.

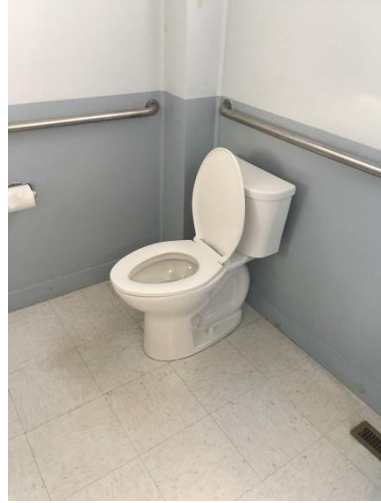
Plumbing: Plumbing fixtures are ADA compliant with the exception of the flush handle on the toilet is located on the wrong side of the tank. There is a 6 Gallon electric water heater in the basement to heat domestic water.

ADA Toilet flush handle on wrong side of tank

Replace all plumbing fixtures with ADA compliant fixtures.

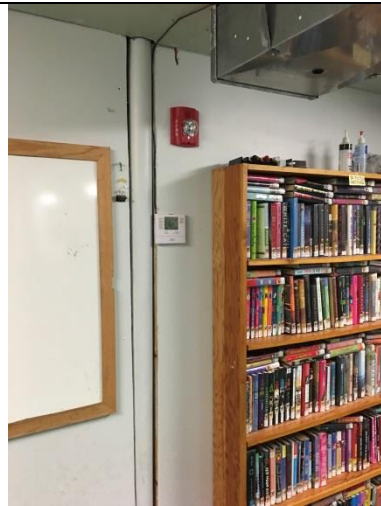
**Fire Alarm System:** The fire alarm devices in this building are connected back to a central panel located in the Annex Building. There are horn/strobes located throughout the facility but does not comply with current NFPA and ADA codes. Additional devices need to be added to bring the system up to current NFPA and ADA codes.

Typical horn strobe
