November 15, 2016

**Re: *Lee Municipal Buildings***  
***7 Mast Rd., Lee, NH***  
***Structural Review***

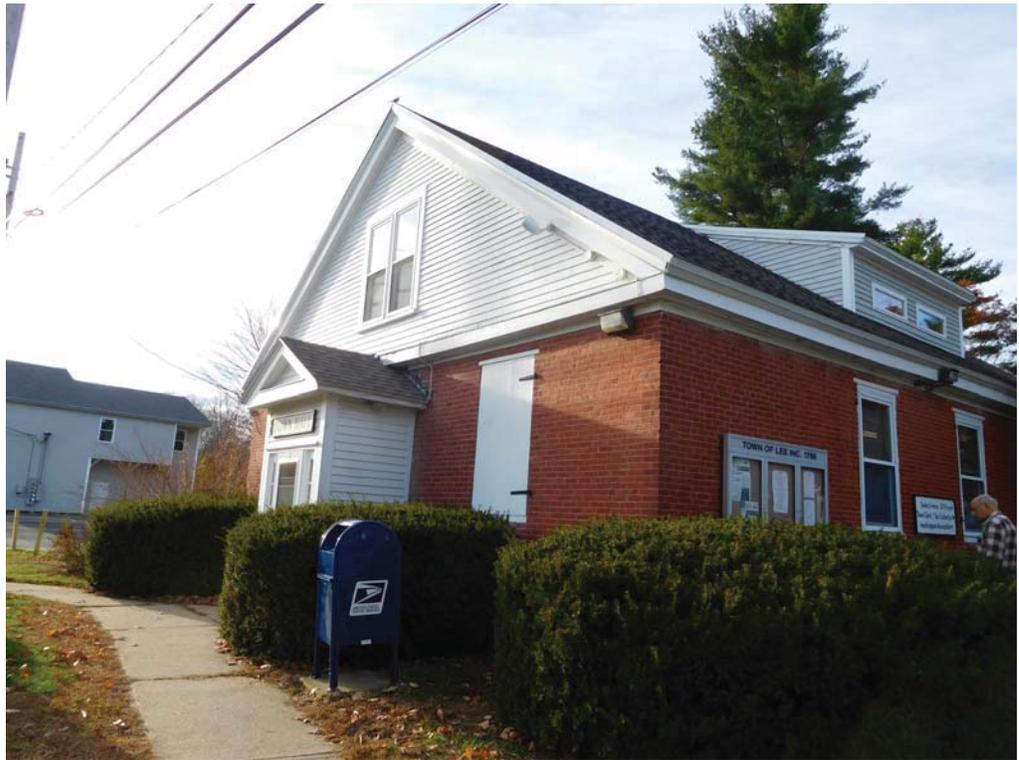
The town hall is a 2-story wood framed building with brick veneer exterior walls that originally was an old school house built in the mid 1840's. The second story is within the attic. A wood framed addition was added to the back end of the building in 1968. Exterior views of the building are shown in Photo #1 and #5.

Photo #1 – Town Hall Building

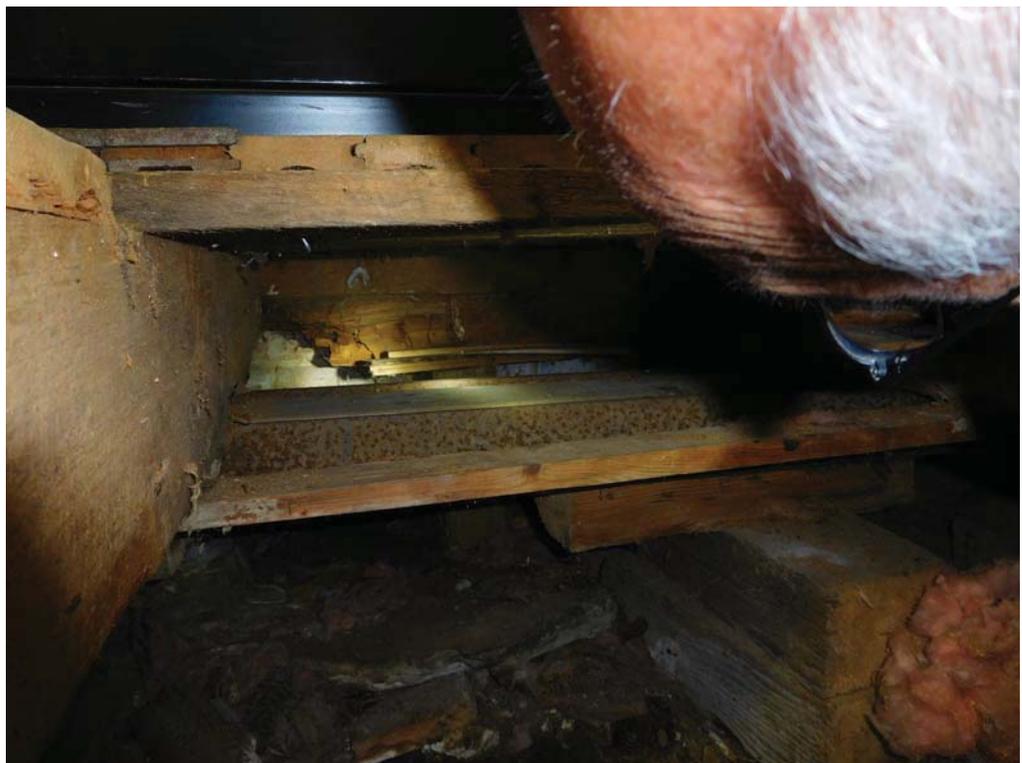
There was concern by the town about the condition of the first-floor framing, which can be observed in the crawl space. This space is extremely tight and shallow; however, I was able to observe some of the framing via a small access panel in the floor on the west side. Upon observation, it became very obvious that a substantial amount of shoring work had been done in this space. First, the exterior sills appear to have rotted some time ago, as well as the ends of the timber joists that mortise into them. Along the west wall a steel I-beam had been installed on its side, blocked with wood on both sides, and supported by pressure treated (PT) dunnage and concrete blocks spaced quite closely together. See Photo #2. This is providing good support for the floor

joists. Since the floor joists mortise into the sill, they are likely still providing adequate support for the wood framed wall. The brick veneer sets directly on the granite foundation so it is supported as well. Depth of foundation for frost protection is unknown.

Photo #2 – I-beam support at perimeter

As noted above, the first floor has been re-supported and does not currently represent any safety issues. It is however, a propped-up floor with rotten sills, no access, and no moisture barrier. A good recommendation for this building for improvement is to lift it and install a new concrete foundation with basement. A qualified building mover could lift it in place so this work could be done. This would provide additional dry storage space and the opportunity to correct damaged framing. At that time, additional review could be done regarding second floor framing and the dormer issue.

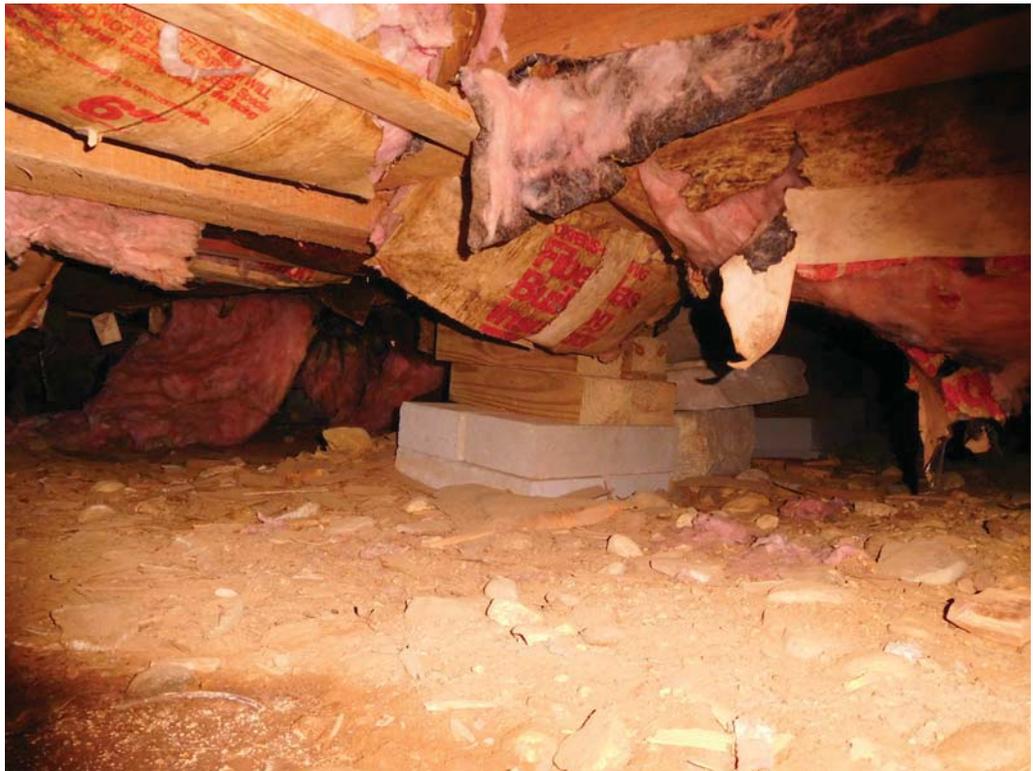
There are a couple of interior timber beam lines that run the length of the building and support the floor joists. PT wood blocking and concrete blocks have been added at numerous locations to support these beams. I was able to crawl to the closest beam and it appeared to be very solid. Photo #3 shows one of these beams and its supports.

Photo #3 – Support of timber beams

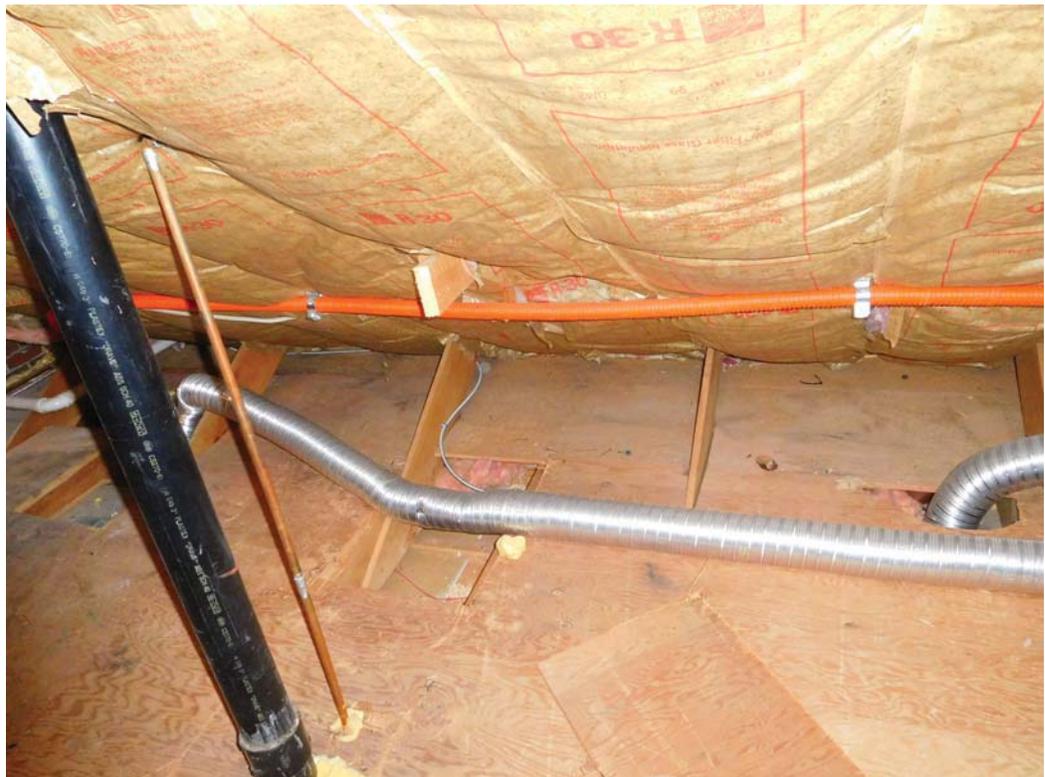
In the addition, standard rafters were used that lean against a ridge board. At the base of the rafters, ties were added to prevent thrust, as seen in Photo #4.

Photo #4 – Addition conventional framing with ties

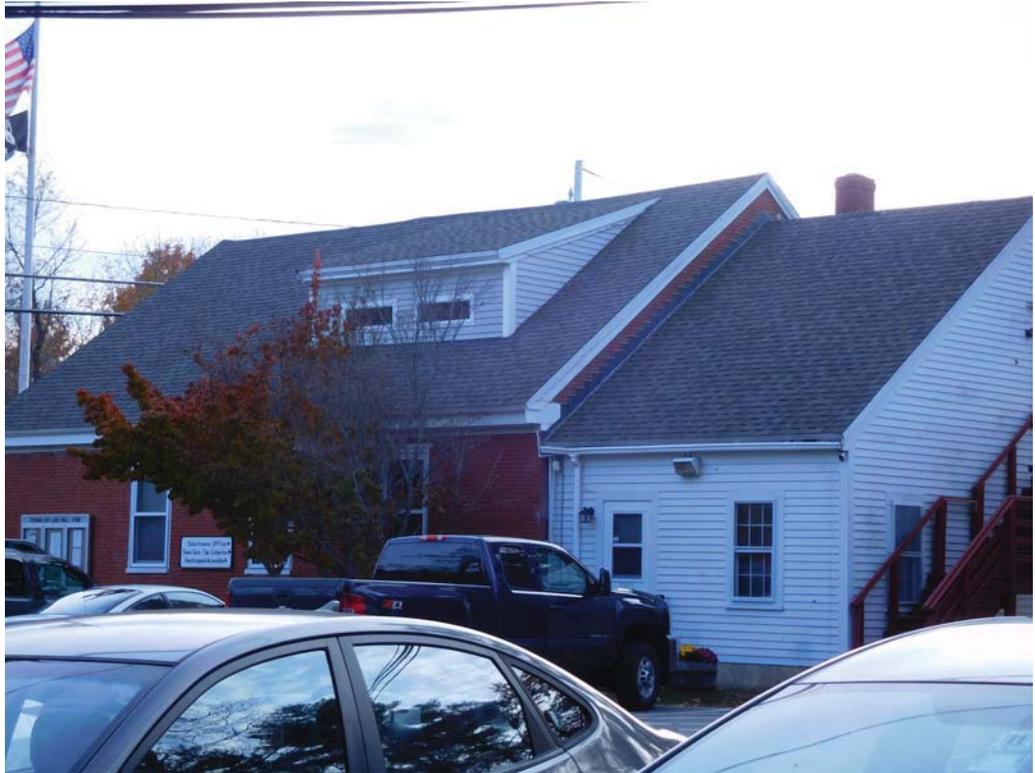
At some time after original construction a shed dormer was added to the front side of the roof. A ridge beam should have been provided at that time, but apparently was not. Due to this, the ridge behind the dormer has a noticeable sag in it, as would be expected. See Photo #5.

Photo #5 – Shed dormer and sag at main ridge

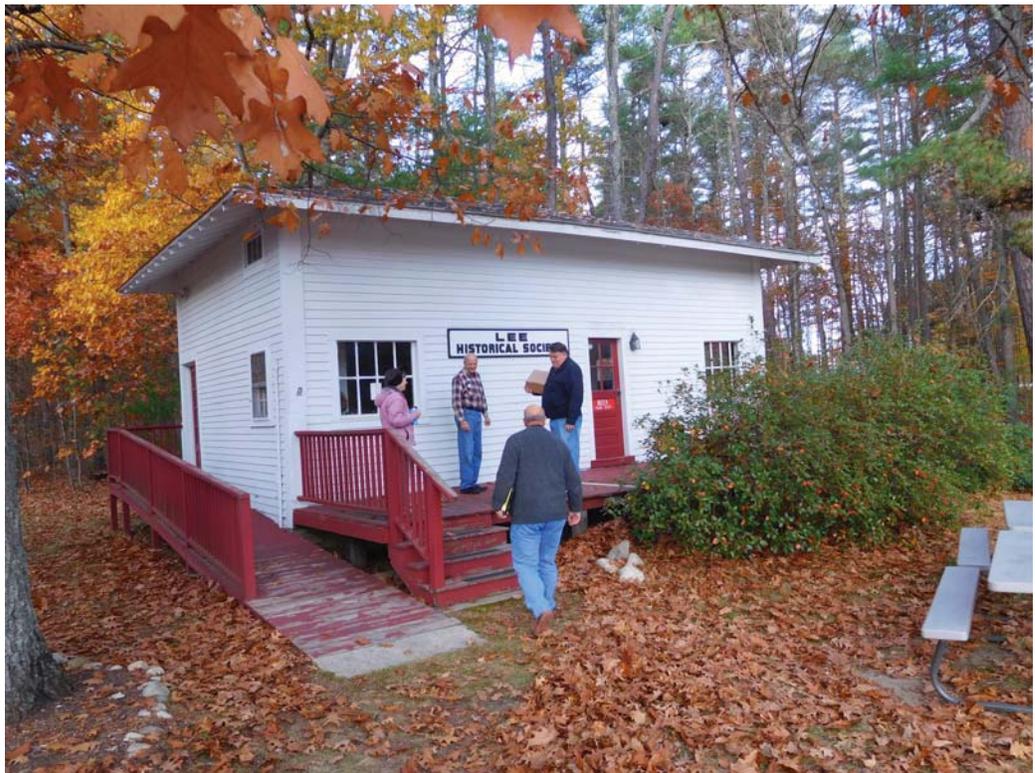
This small building was built in the 1870's and was relocated to this site onto concrete block (CMU) basement walls. See Photo #6. Inside, the second floor is supported by a central beam line with two interior posts. Only one of these posts has a supporting post below it and the other has clearly sagged as seen in Photo #7. In the basement, the framing is clearly visible. The joists appear sound but are very shallow and have some sag as seen in Photo #8. It is apparent that the CMU foundation wall was built without any vertical reinforcing. Photo #9 shows a horizontal crack that has formed from soil pressure pushing the wall inward. This is not a desirable situation for a basement wall. A concrete slab is also present in the basement.

Photo #6 – Historical Society building

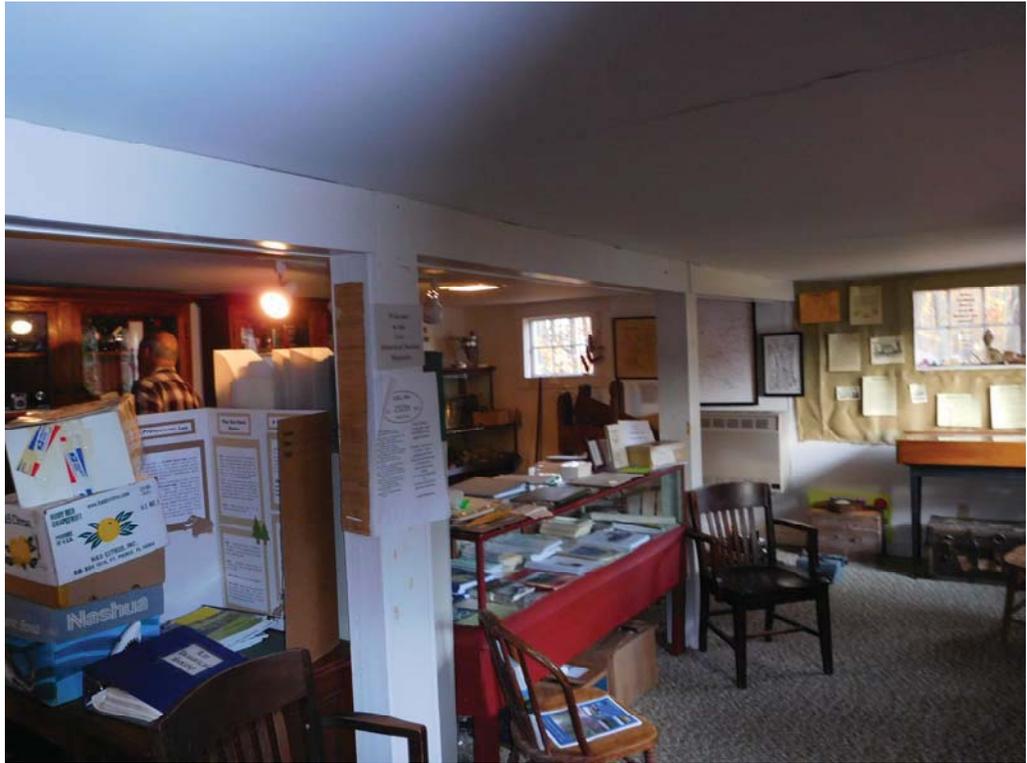
Photo #7 – Sagging 2<sup>nd</sup> floor beam

Regarding the second floor beam, a post should be added in the basement so that they align with and support the posts at the main level. The crack in the CMU foundation wall should be monitored year by year to determine if it is continuing to open wider. If so, reinforcing will be required. The roof structure and tops of walls have deflected, but should be at a stable state at this time.

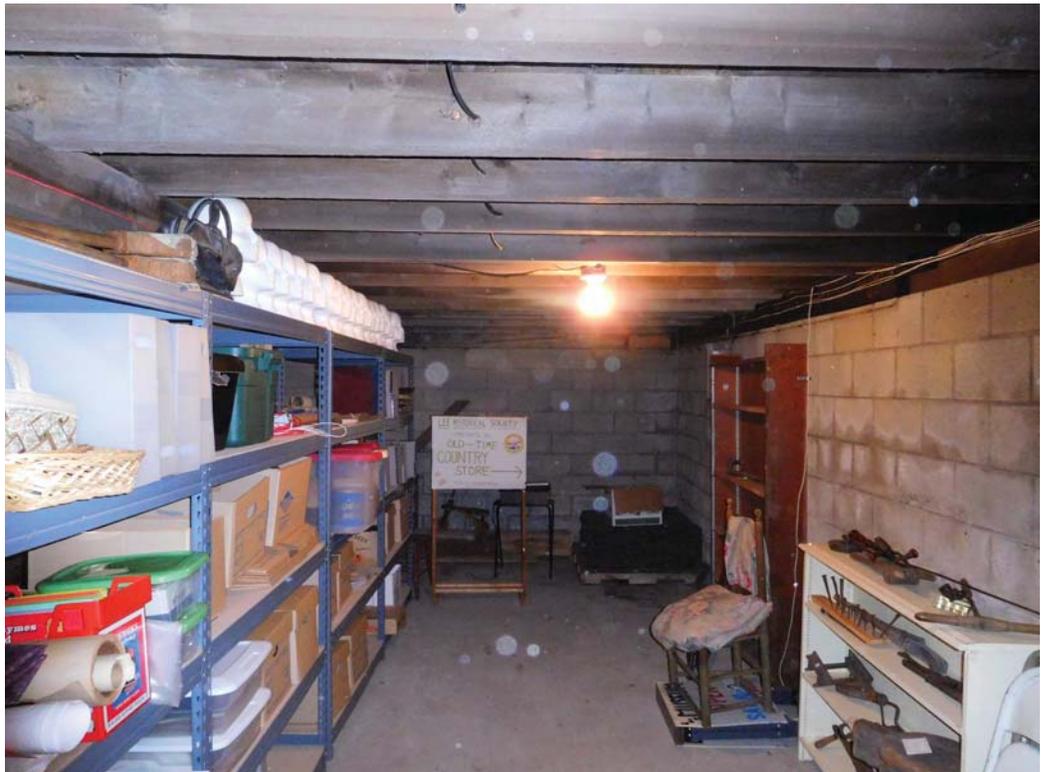
Photo #8 – Shallow joists with sag

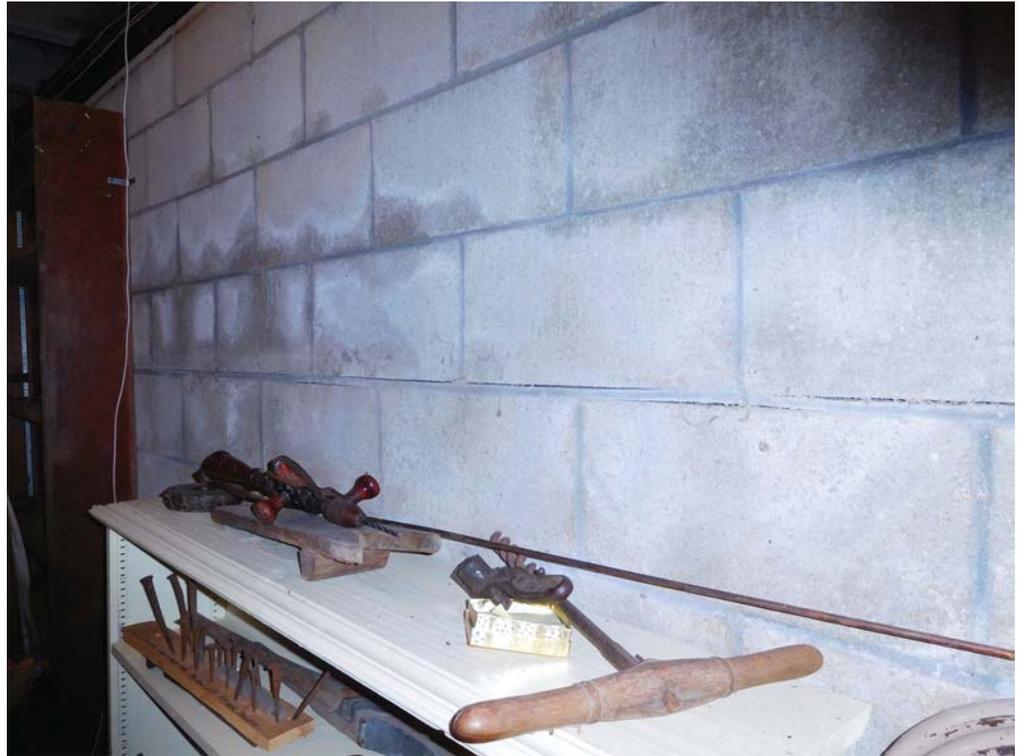
Photo #9 – Horizontal crack in CMU wall

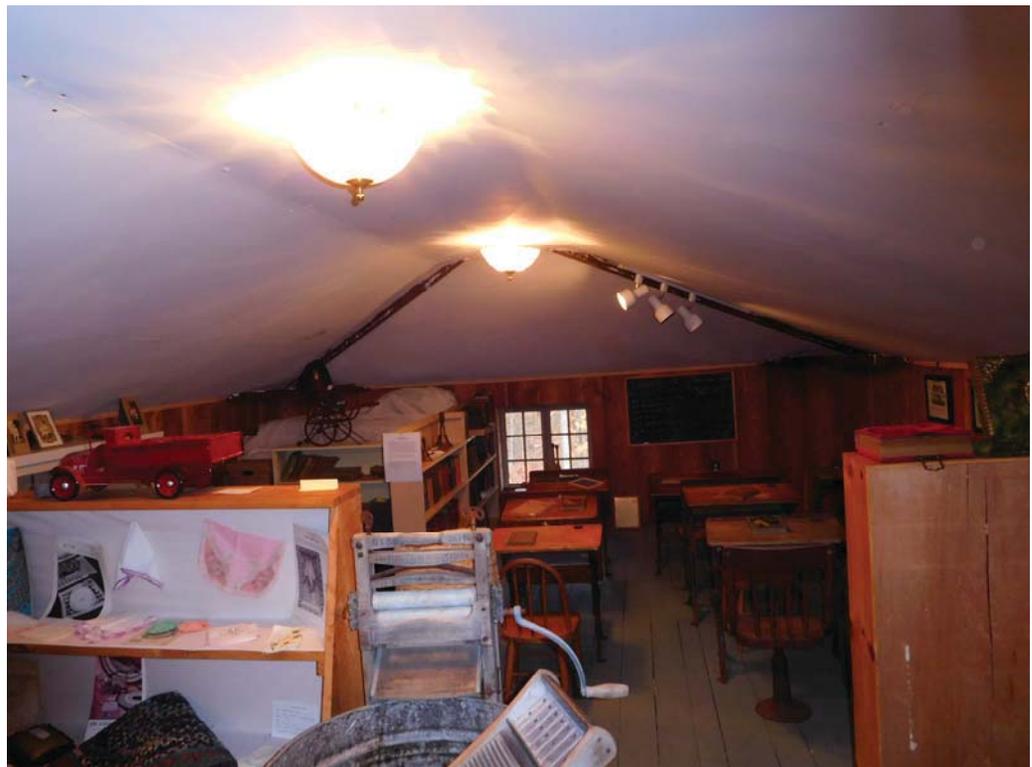
The hip roof is framed with a low-pitch onto balloon framed walls that extend a few feet above the floor as seen in Photo #10. Since there is no ridge support, this structure would expect to deflect outward at the eave. Viewing from outside it is evident that the walls have bowed outward at the eave. The second floor is lightly framed and has a bouncy feel.

Photo #10 – Roof/ceiling in attic

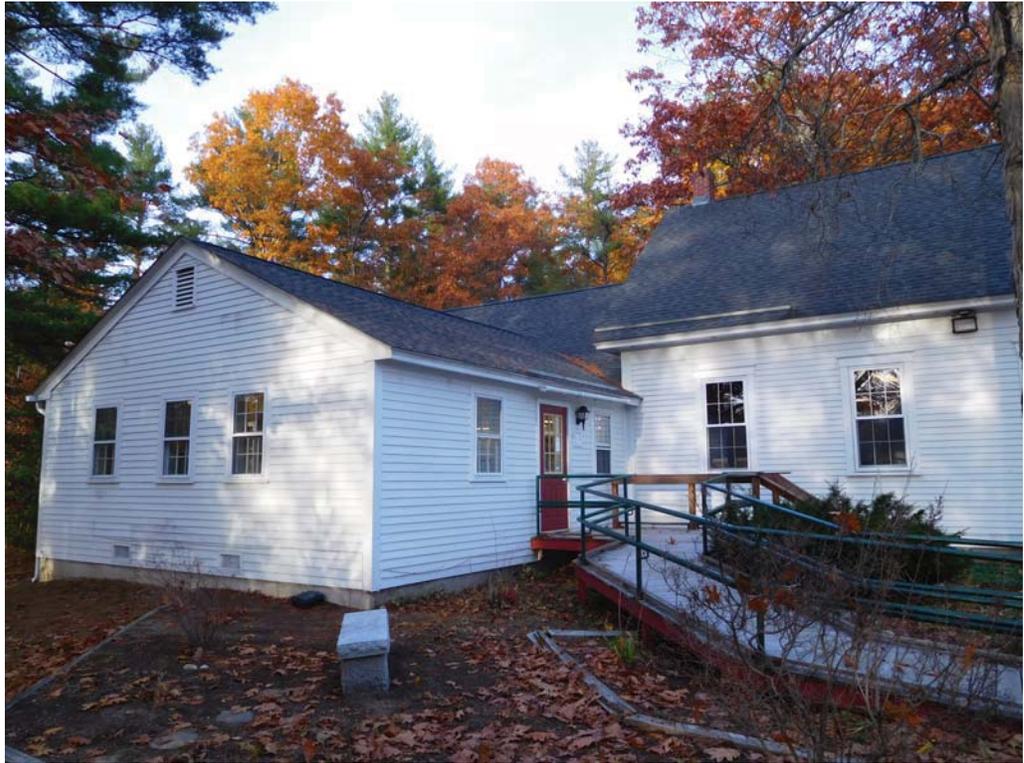
The original Library building was built around the late 1800's as a school house and moved to the site in 1962. Additions were added in the 1970's and 1990's. The original building appears very sound and is seen at the right side of Photo #11. It is two stories of timber frame on a concrete foundation wall. There are two courses of CMU on top of the concrete foundation that the timber frame bears on. In the basement, the framing is visible as seen in Photo #12. In many places joist hangers have been added to reinforce the original mortised connection of joist to beam. Some timber posts are present, and some adjustable steel lally columns have been added. The space appears dry and the framing appears sound.

The 1970's addition is seen in the front left of Photo #11, and the 1990's addition is behind it. The 1972 addition has a crawl space but it was not accessible. The 1990's addition has a basement but all framing is covered with sheetrock. Apparently the 1990's portion was designed for book stack loads.

Photo #11 – Library and additions

There are no particular recommendations at this time. If additional capacity is desired for book stacks in the original building, reinforcing could easily be done in the basement.

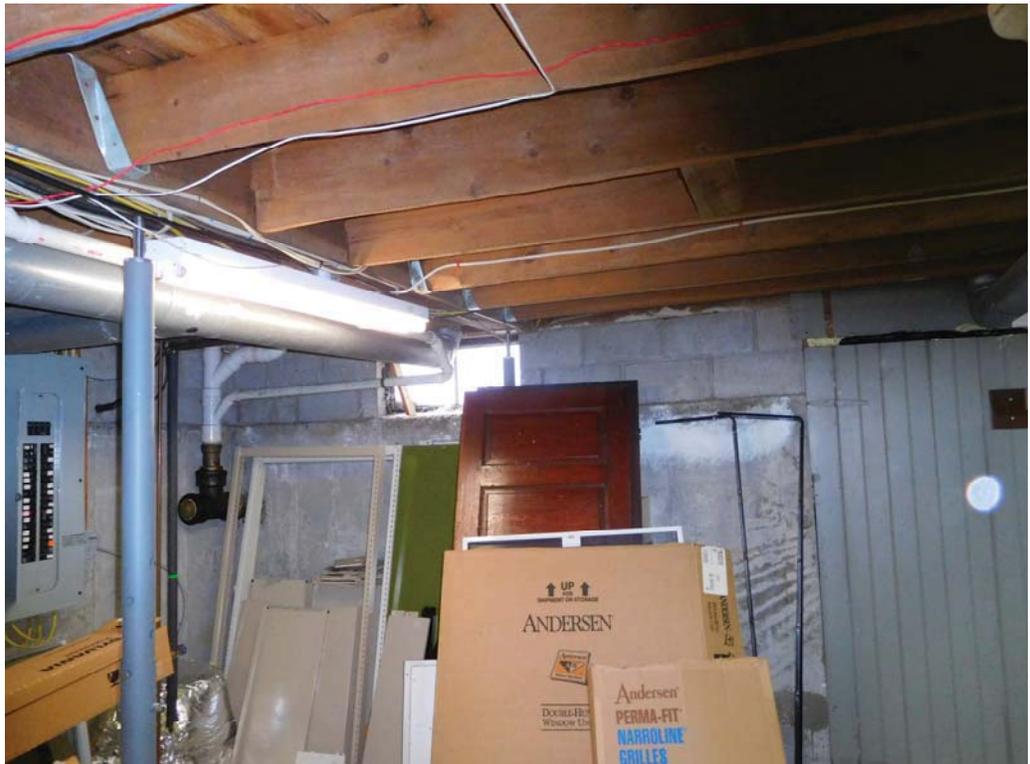
Photo #12 – Basement of original building

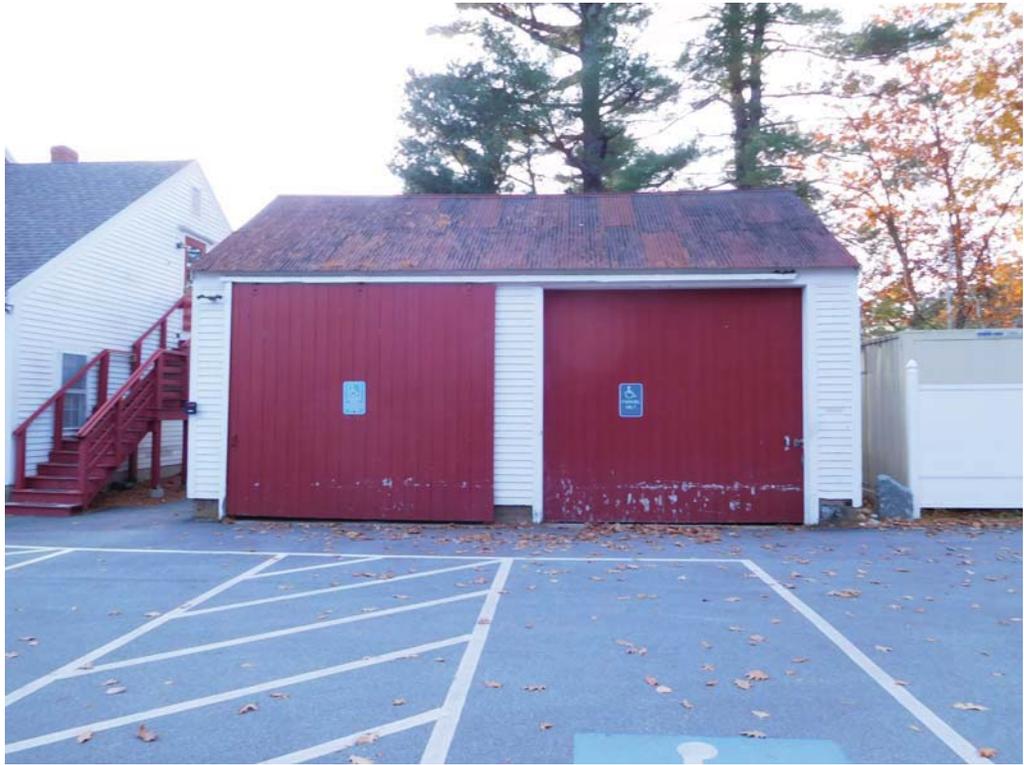
This small building is referred to as the Hobo shed, and is seen in Photo #13. It is a two-bay garage with large sliding doors; one on the outside and one on the inside. It has a corrugated metal roof that is quite rusty. A shed style addition was added to the rear. It all rests on a CMU foundation. This building is in satisfactory condition but needs some attention. The roof construction is quite light but has lasted this long. The timber rafters bear together at the ridge, and only two timber ties run across to prevent from spreading. There is some diagonal bracing but is located rather haphazardly. See Photo #14.

Photo #13 – Hobo shed

This is not an essential building but seems to have historic value and emotional attachment. It's a very quaint building with a colorful history. This building could easily be moved and repaired or renovated. The logistics of moving it would vary with contractors, but it could be moved in whole or in parts and put back together.

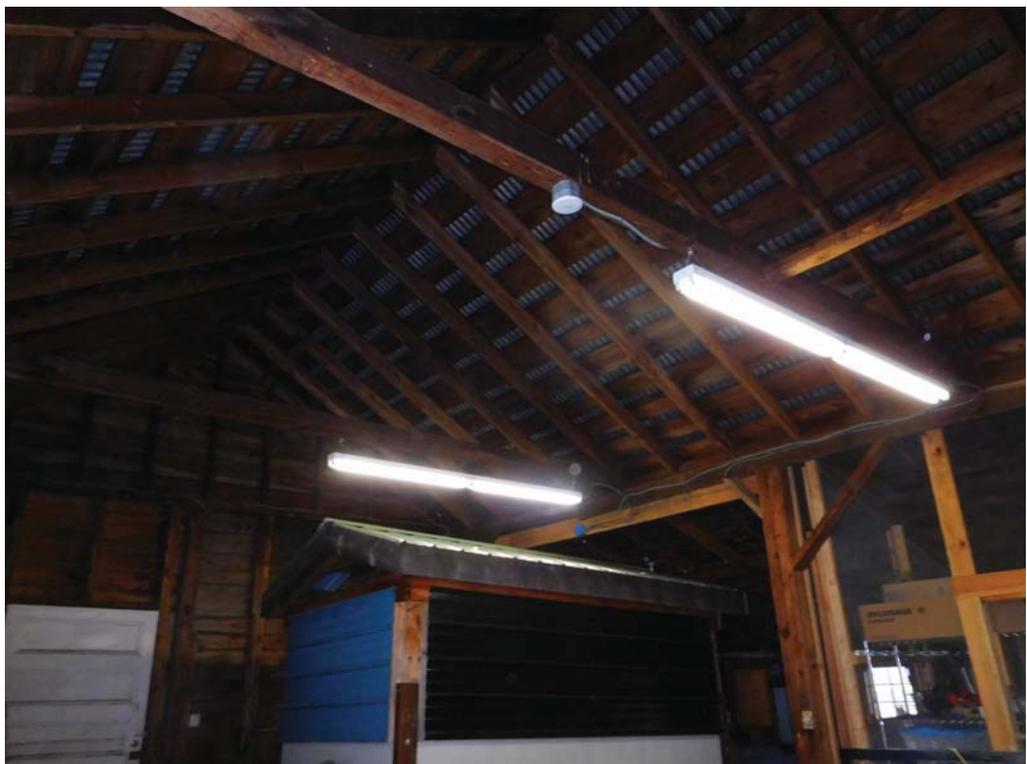
Photo #14 – Roof structure

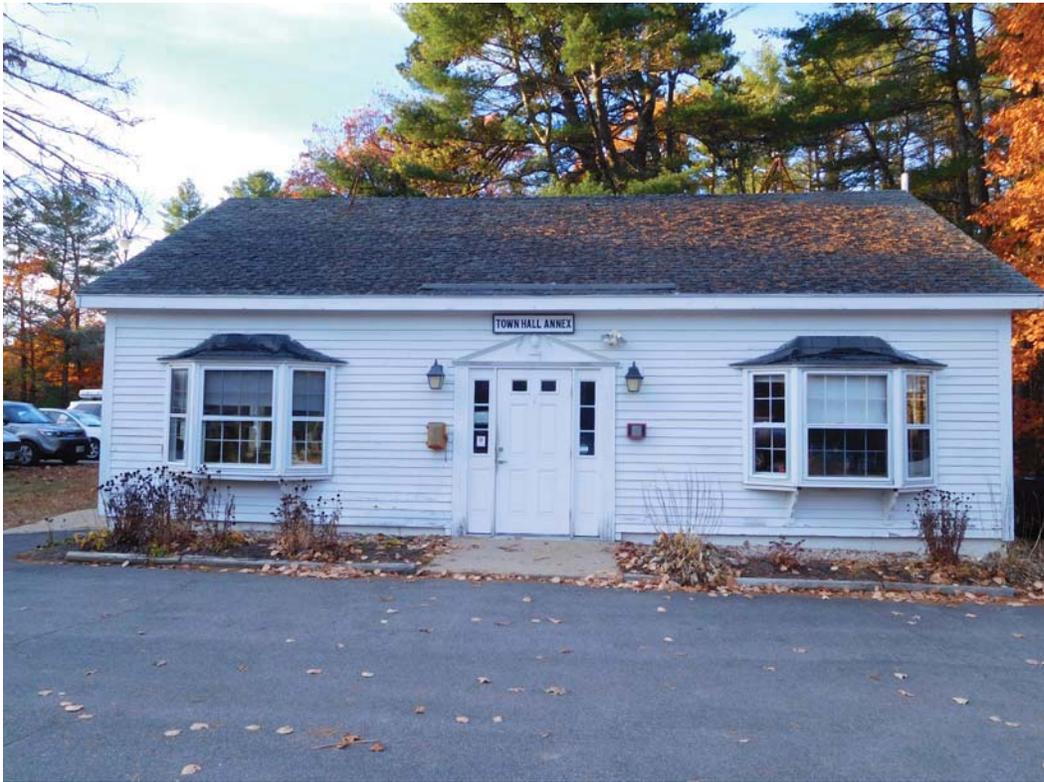
around 1954 as a fire department and is a one-story saltbox with attic, however the attic was not accessible. See Photo #15. All of the structure is covered with finishes. The floor is concrete slab-on-grade and is very unlevel. The foundation is old concrete. The front roof slope looks fine structurally, but the shingles are far past their useful lifetime. The rear slope has a noticeable bow to it.

Photo #15 - Annex

We have no recommendations for this structure at this point. If it has historic value it certainly could be renovated appropriately.
