LEE TOWN CENTER MUNICIPAL FACILITIES

LEE TOWN CENTER
MUNICIPAL FACILITIES

Presented by LEE SELECT BOARD, LEE FACILITIES COMMITTEE
ART GUADANO, AIA, LEED AP BD+C

Town of Lee
Municipal Facilities Needs Study
AG Architects Project No. 16-704.0
28 November 2016

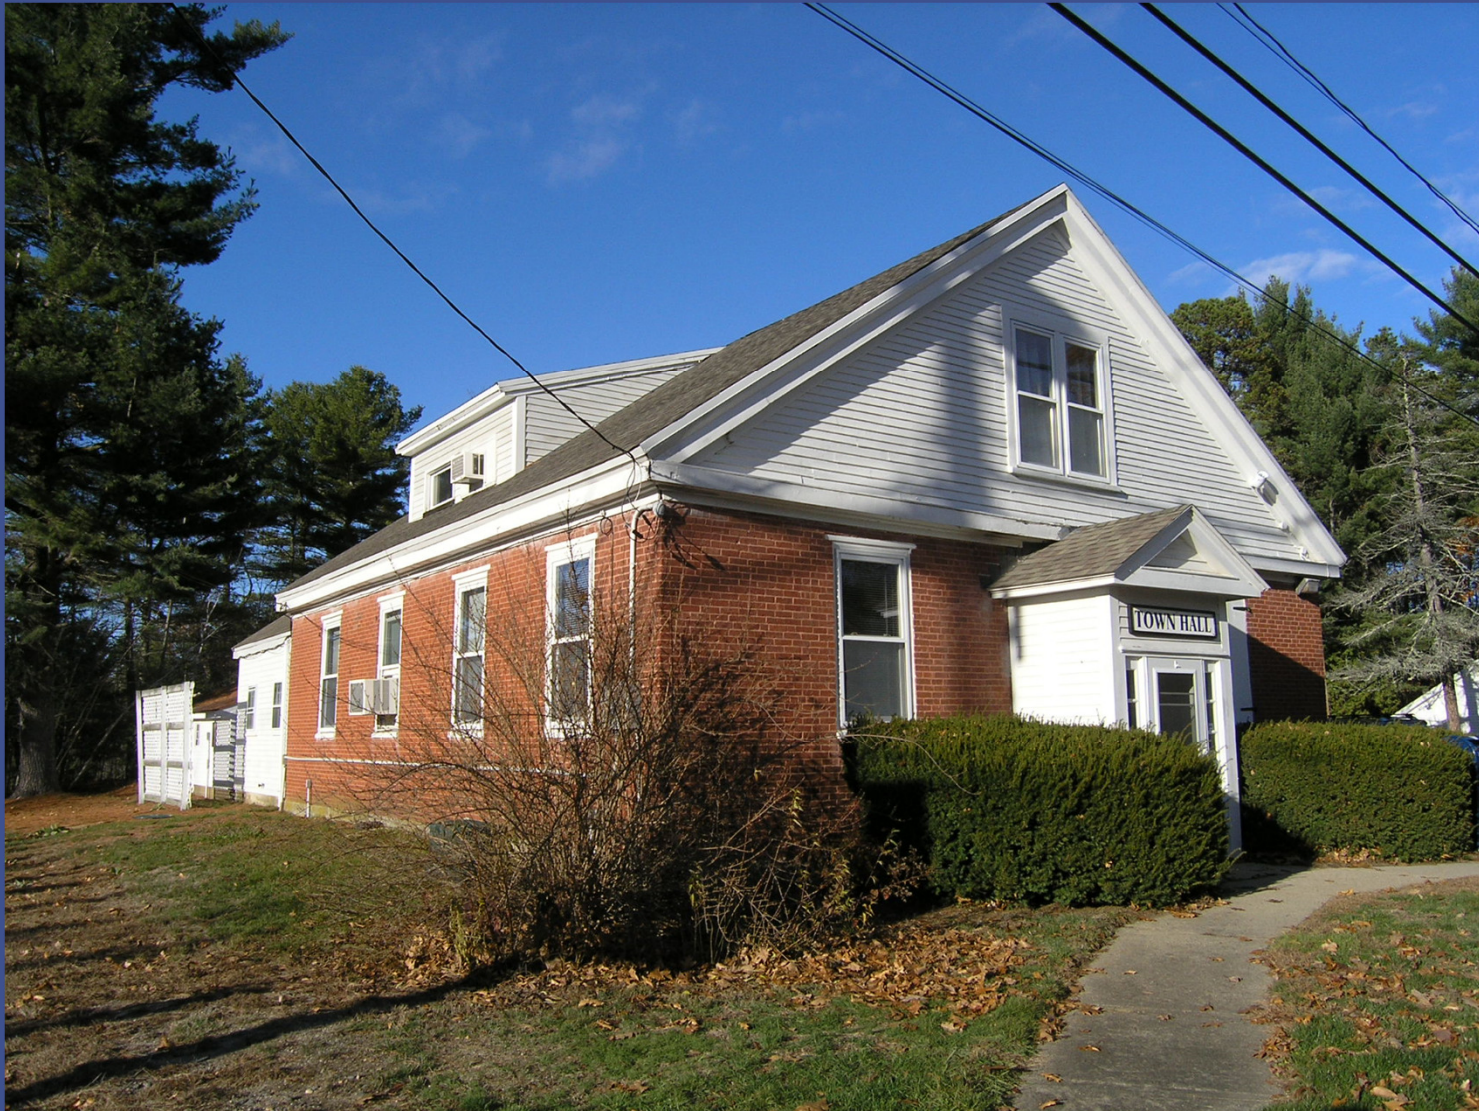
Building Evaluations – Town Hall

- Rotted Floor Beams
- Dirt Crawl Space
 - Moisture Problem
- Poorly Insulated Floor
- Unvented Crawl Space
 - Causes Rot

- ❑ Inadequate Framing Second Floor Dormer
- ❑ Roof Sag at Dormer
- ❑ Boiler is Standard Efficiency Propane-Fired Boiler
- ❑ Electrical Romex NM Wiring in Poor Condition
- ❑ Inadequate Quantity of Outlets
- ❑ Inadequate and Ineffective T12 Fluorescent Lighting

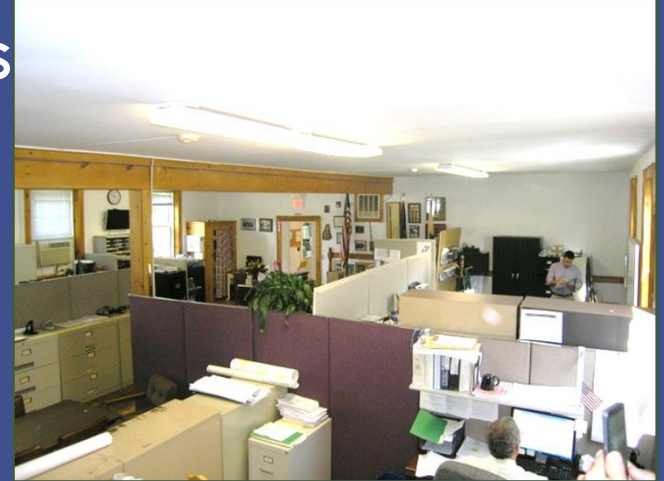
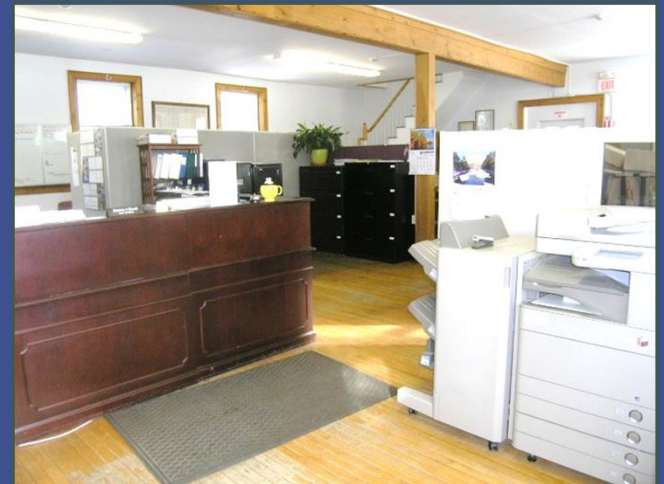
Lack of Adequate Space – Town Hall

- No Privacy for Staff or Meetings
 - ▣ Administration
 - ▣ Welfare
 - ▣ Finance
 - ▣ Conference
- No Control of Public Access to Offices
- Server Located in Attic Eaves
 - ▣ Poorly Air Conditioned

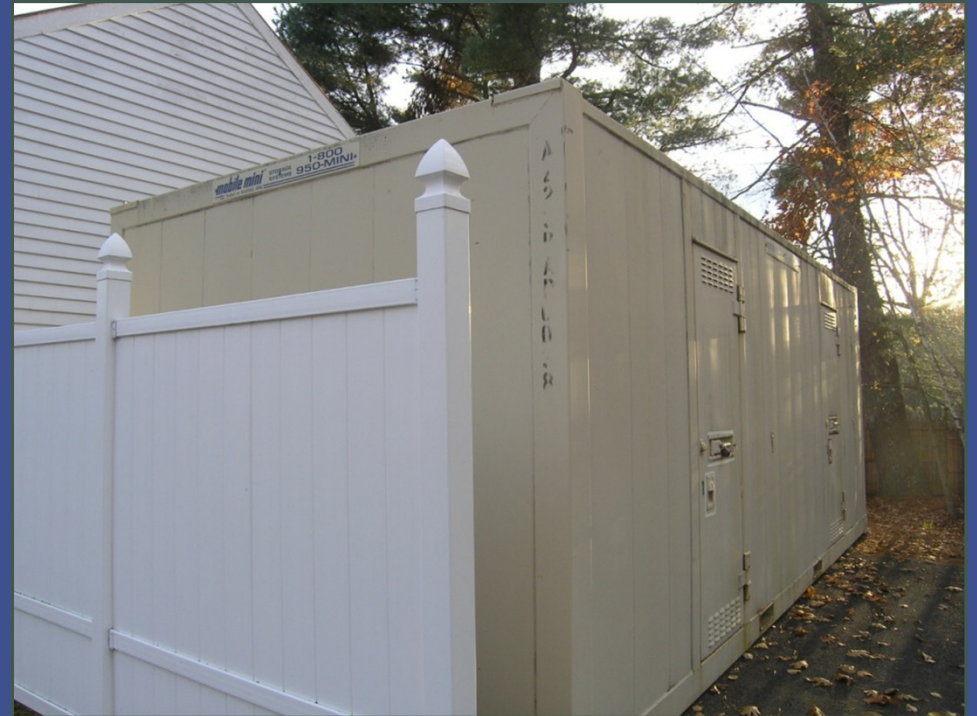
Lack of Adequate Space – Town Hall

- Storage for Town Records in a Storage Container
 - Leaks
 - No heat/climate control
 - Poor environment for maintaining records

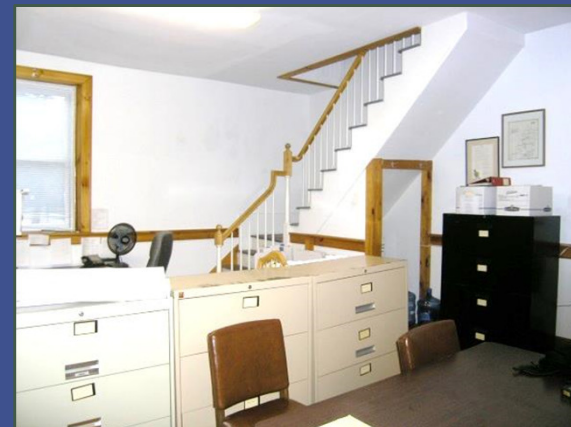
Code Compliance Issues – Town Hall

- ADA Building Accessibility
 - Does not meet 60% of accessible entrances
 - Does not provide Automatic Door Openers
 - Ramp entrance does not meet Standards
- No ADA Compliant Access to Second Floor
- Lacking Two Code Compliant Exits From Second Floor

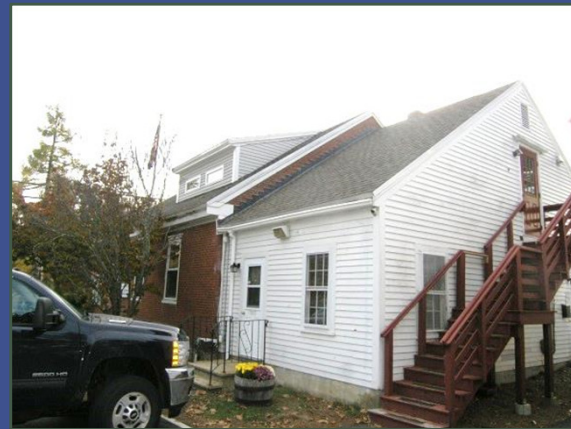
Code Compliance Issues – Town Hall

- ❑ No Mechanical Fresh Air Ventilation
- ❑ Lacking Adequate Exit Signs and Emergency Lighting
- ❑ Inadequate Number of Toilet Facilities
 - ▣ Only One Public Toilet
 - ▣ No Drinking Fountain
- ❑ Several Windows Non-Insulated Glass with Storms

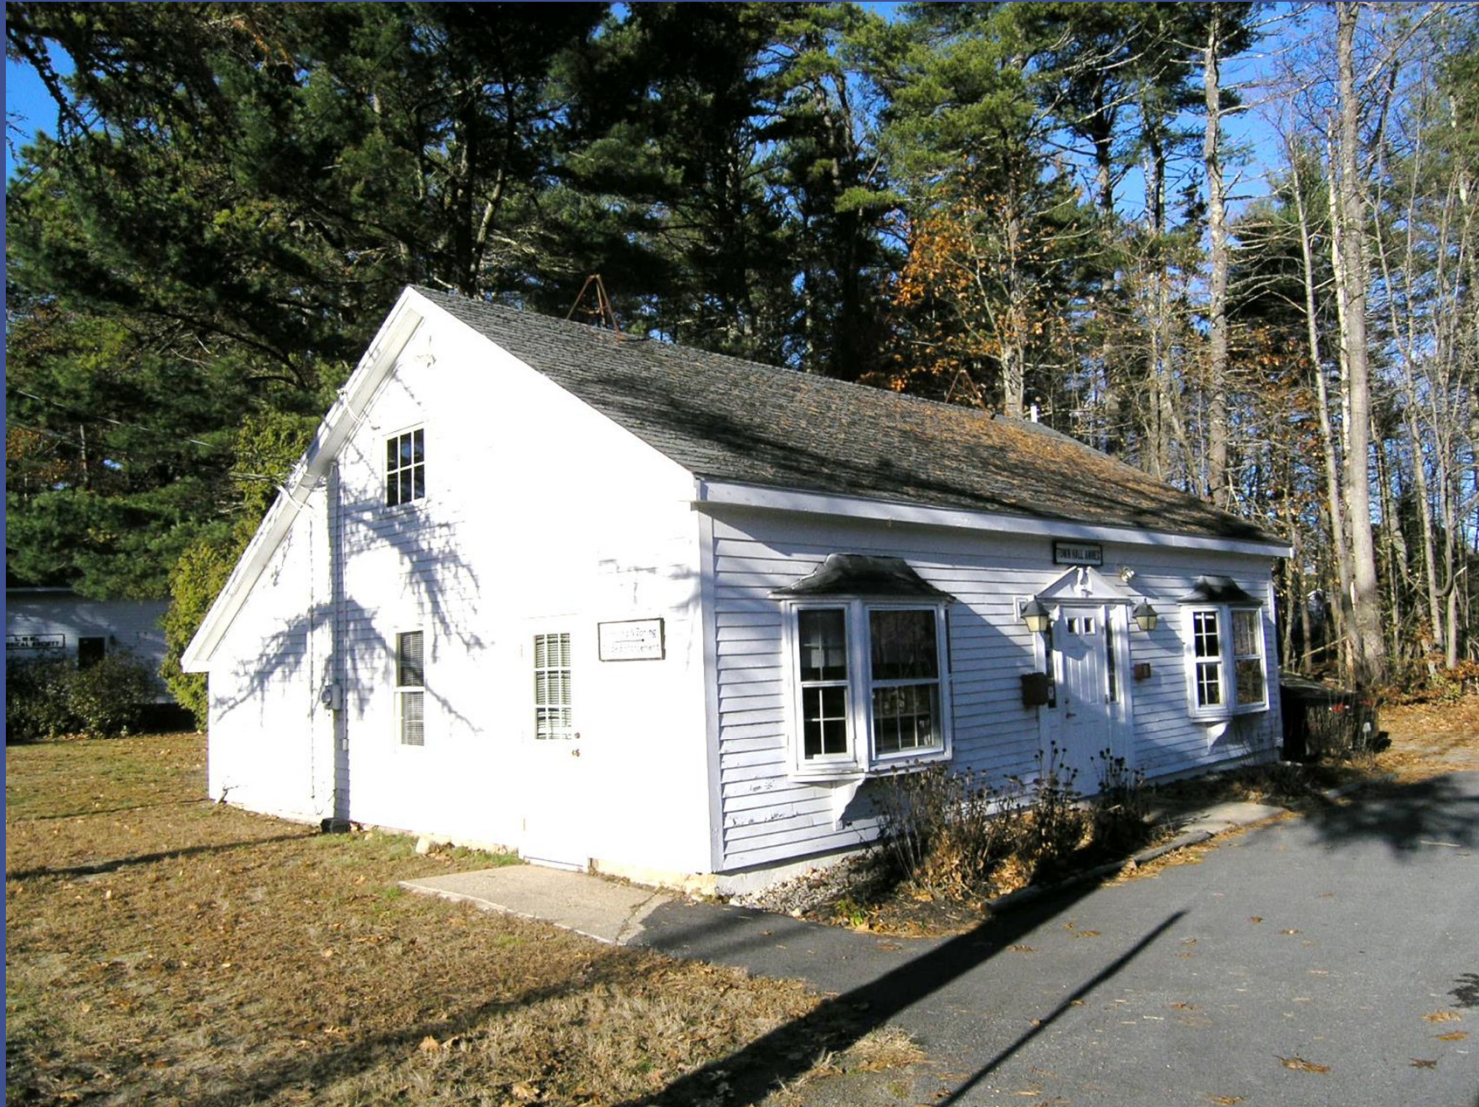
Building Evaluations – Annex

- ❑ Roof Shingles In Poor Condition
- ❑ Existing Concrete Slab-on-Grade is Uneven
- ❑ Inefficient and Ineffective T12 Fluorescent Light Fixtures
- ❑ Boiler is Standard Efficiency Propane-Fired Boiler
- ❑ Parking Spaces Require Backing into Road
- ❑ Inadequate Bathroom Exhaust Ventilation

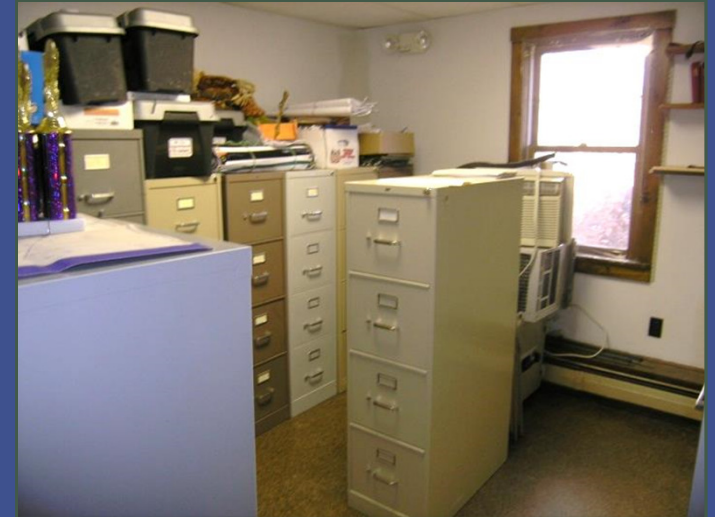
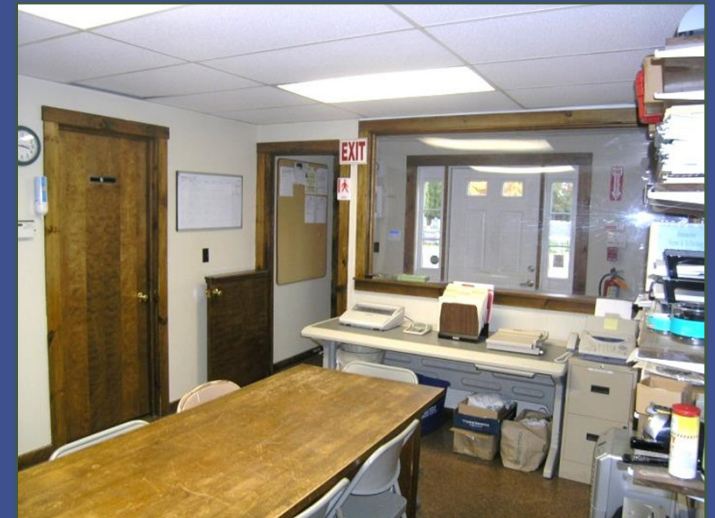
Lack of Adequate Space – Annex

- ❑ Lack of File Space
- ❑ Conference Table in Middle of General Work Space

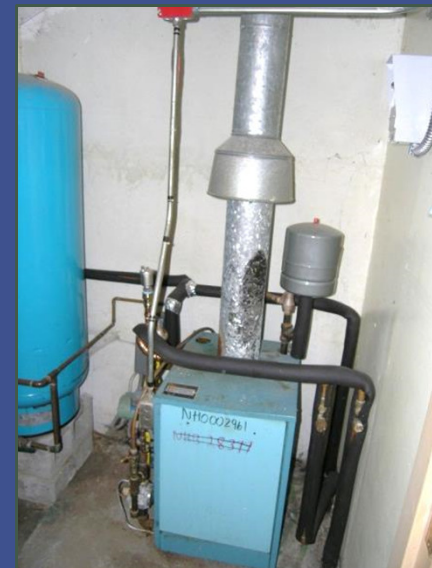
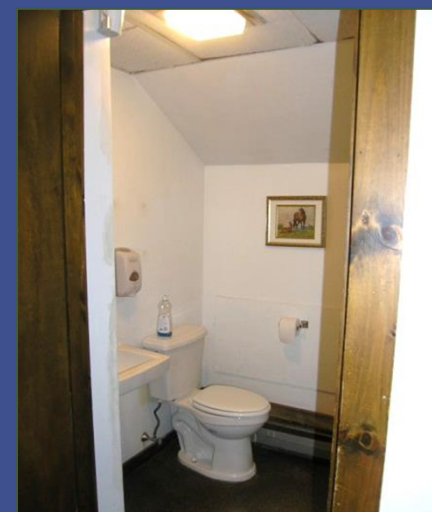
Code Compliance Issues – Annex

- ADA Building Accessibility
 - Front vestibule and counter not accessible
 - Does not provide Automatic Door Opener
- Bathroom Not Accessible Per ADA
 - Only one non-accessible bathroom
 - No drinking fountains
- No Mechanical Fresh Air Ventilation
- Lacking Proper Exit Signs and Emergency Lighting

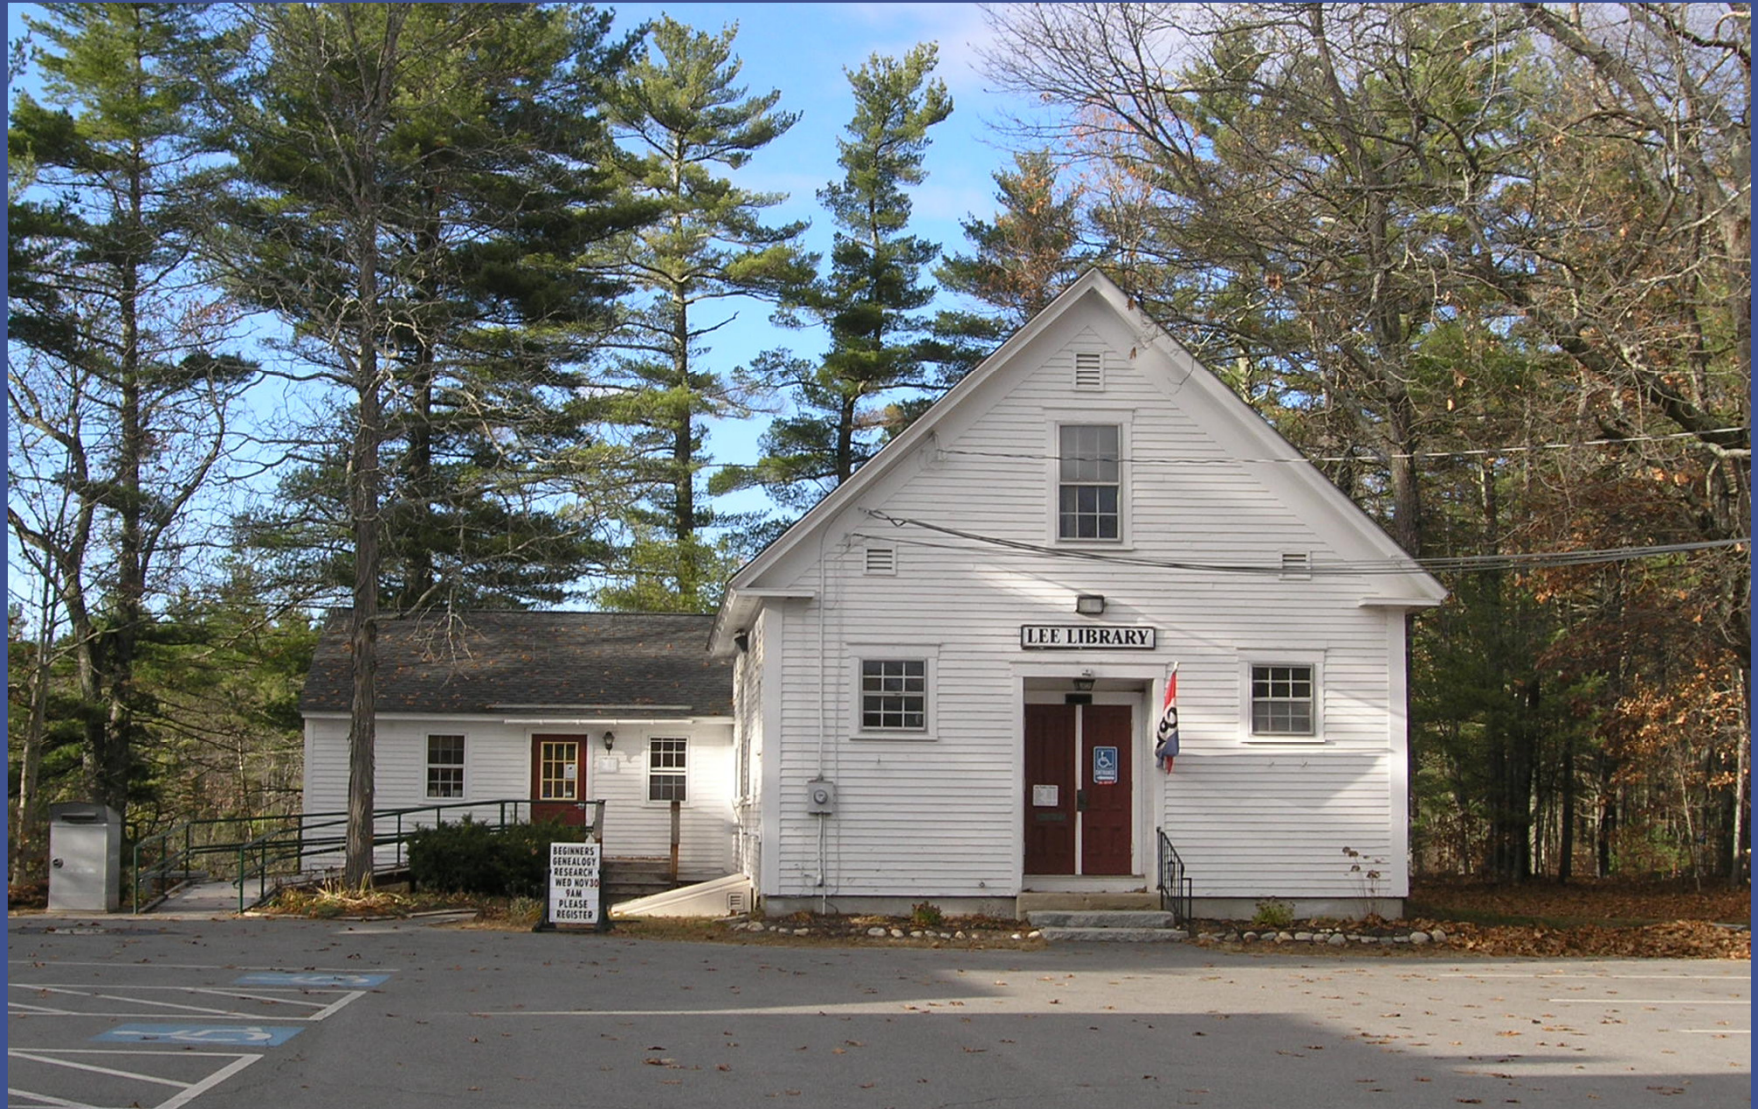
Building Evaluations – Lee Public Library

- Portions of Building Floor Structure Inadequate for Library Stack Loads
- Lack of Insulation (Basements)
- Inadequate and Inefficient T8/T12 Fluorescent Lighting
- Some Older Windows
 - Non-insulated glass with storm windows

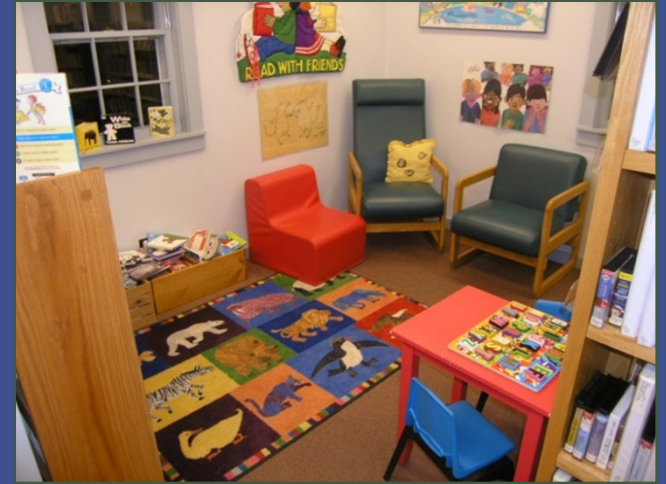
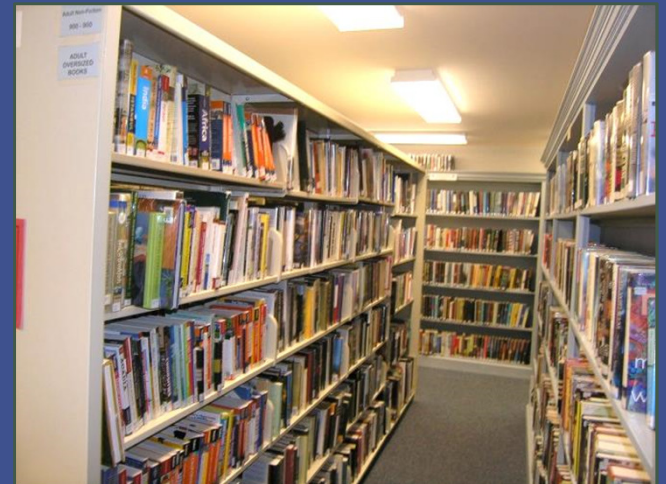
Lack of Adequate Space – Library

- ❑ Children's Room Inadequate Area
- ❑ Limited Number of Volumes
 - ▣ Collection 24,895 volumes
 - ▣ Limited children's volumes
 - ▣ Young adult volumes – Only (3) double sided 3' shelves
 - ▣ Lacking sufficient adult fiction/non-fiction volumes

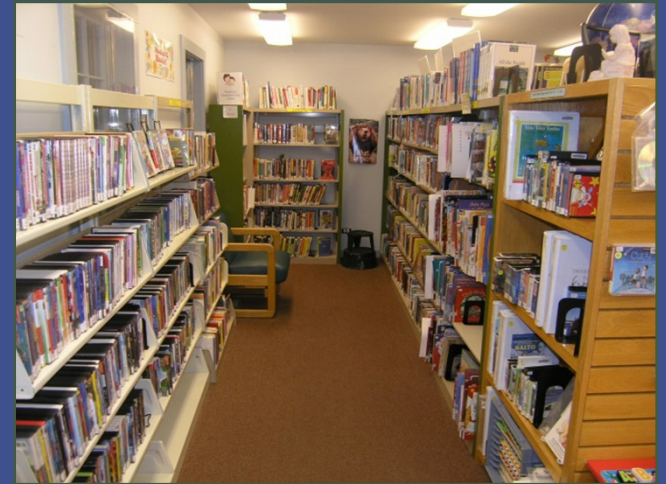
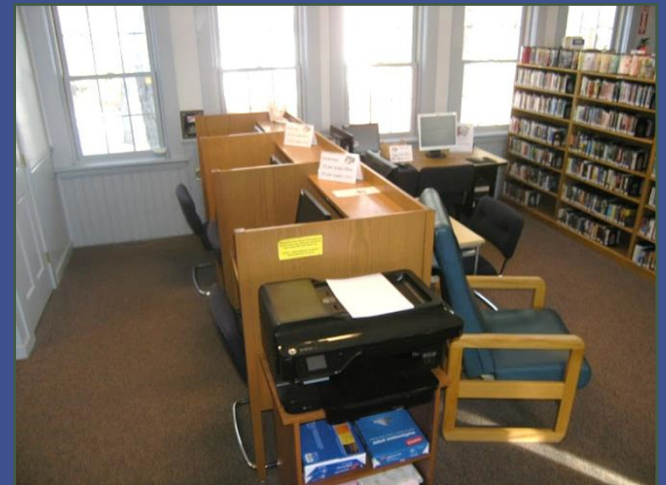
Lack of Adequate Space – Library

- ❑ Children's Shelves Too High To Reach Books
- ❑ 6 Computer Stations Often Fully Utilized
- ❑ Lacking Space to Move
 - ❑ Narrow Aisles
 - ❑ No Display Space
- ❑ Limited Seating/ Reading Areas

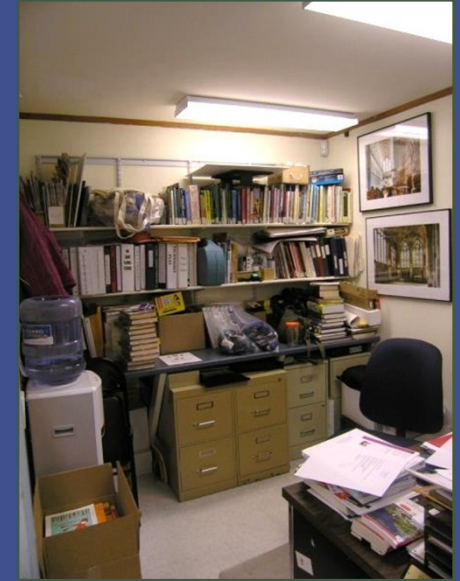
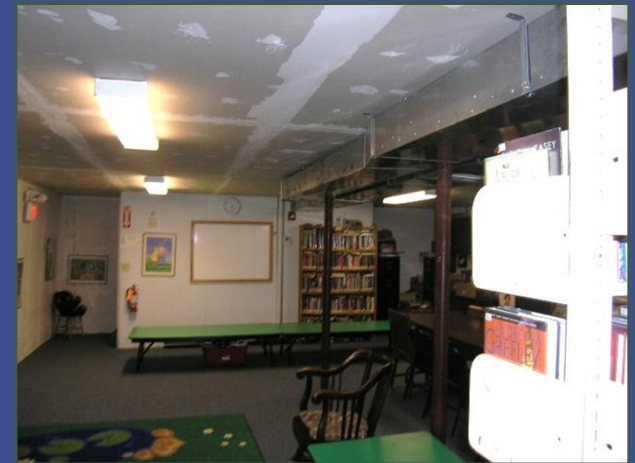
Lack of Adequate Space – Library

- ❑ Staff Office Space Inadequate
- ❑ No Staff Break Room
- ❑ Inadequate and ADA Inaccessible Meeting Space
- ❑ 300 Meetings Per Year:
 - ▣ Lectures/Talks
 - ▣ Crafts Programs

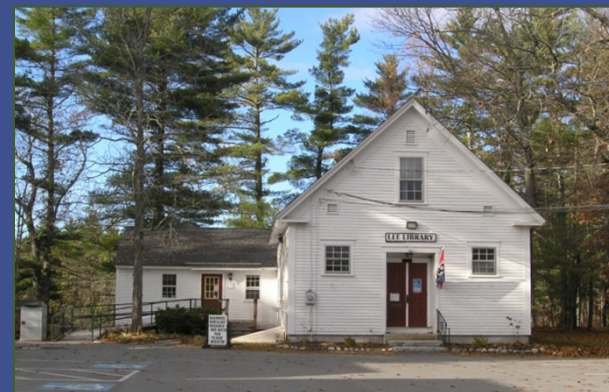
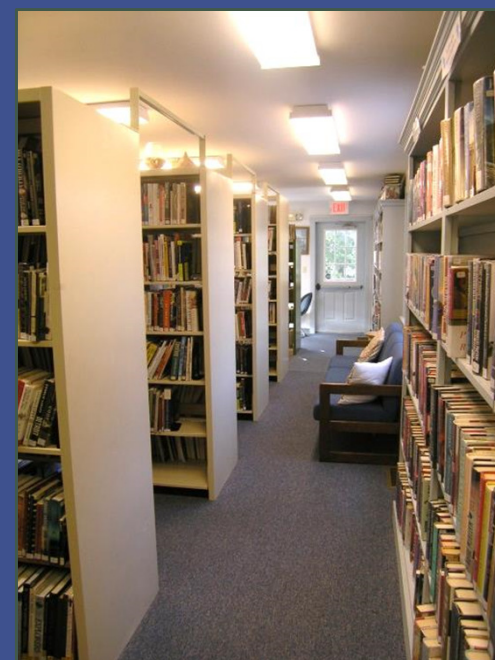
Code Compliance Issues – Library

- ❑ ADA Building Accessibility
 - ❑ Does not meet 60% accessible entrances (Currently 25%)
 - ❑ Does not provide Automatic Door Opener
- ❑ Basements are Not Accessible Per ADA
- ❑ Stack Aisles Lack ADA Turnaround Space
- ❑ Stairs Do Not Comply with Building Code
 - ❑ Landing, Tread/Riser Dimensions
 - ❑ Door Swings

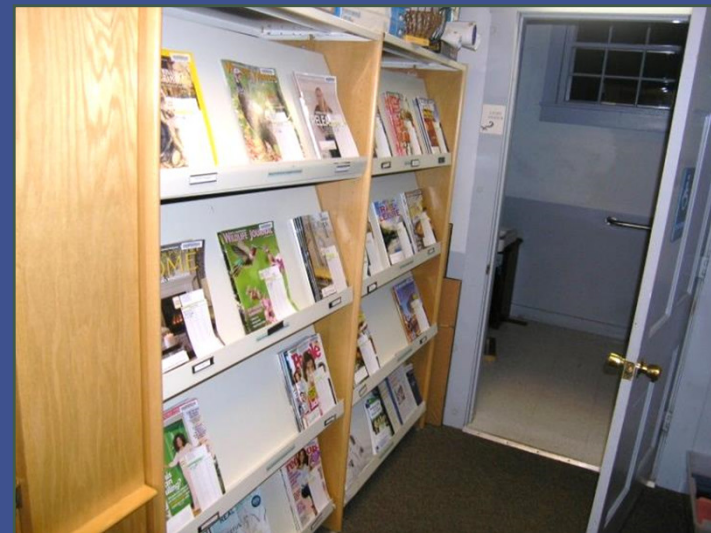
Code Compliance Issues – Library

- ❑ No Fresh Air Ventilation
- ❑ Inadequate Number of Toilet Facilities
 - ▣ Only One Public Toilet
 - ▣ No Drinking Fountains
- ❑ Bathroom Not Fully ADA Compliant

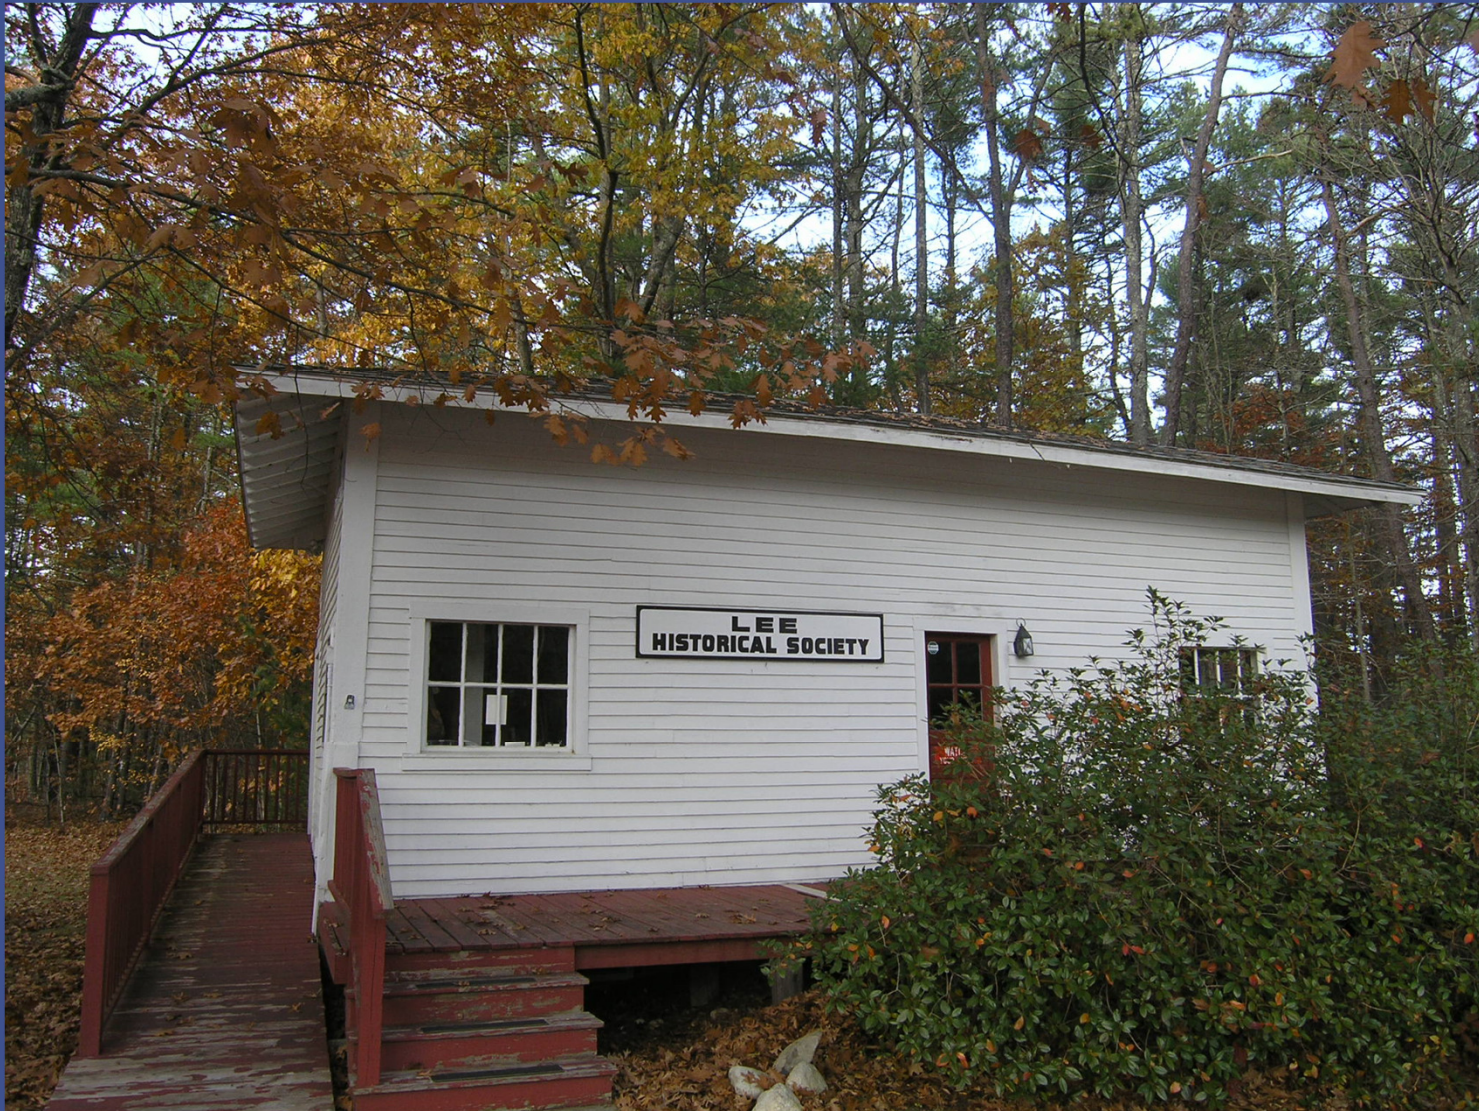
Building Evaluations – Historical Society

- Unreinforced Concrete Block Foundation
 - Cracked, Bowing inwards, Leaking
- Sagging Second Floor Beam
 - No basement post support
- Basement Damp
 - No ventilation for stored materials, including textiles

- Limited Heating
 - Propane-fired wall heater
 - No air conditioning
 - Collection condition at risk due to lack of climate control
- Limited and Inefficient Incandescent Lighting

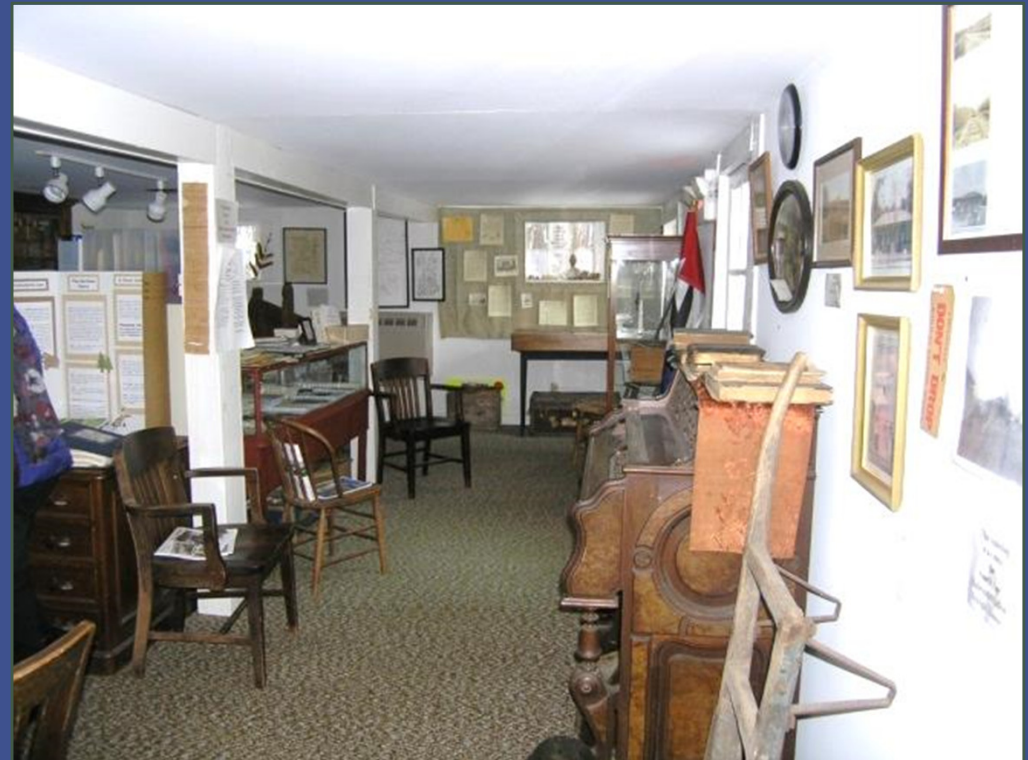
Lack of Adequate Space – Historical Society

- Major Lack of Display Space
 - Losing ability to obtain additional collection items
- No Office Space or Records Storage Space
 - Use museum pieces for working surface
- No Space for Public to Research Records

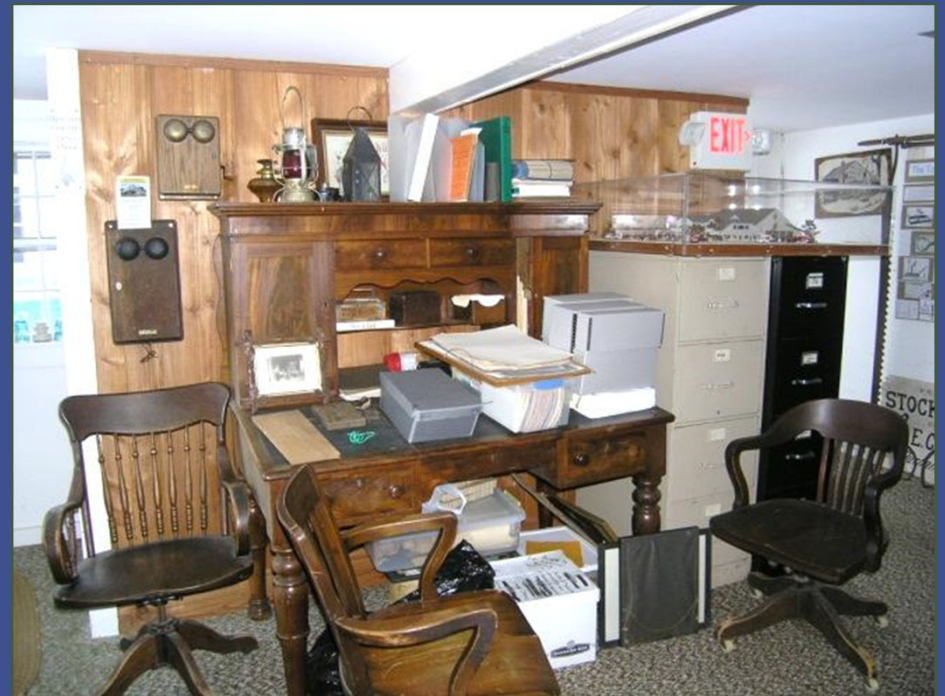
Lack of Adequate Space – Historical Society

- No Space for Occasional Meetings or Programs
- No Storage Area for Large Exhibits
 - Farm Machinery
 - Horse Drawn Snow Roller
 - Wagons

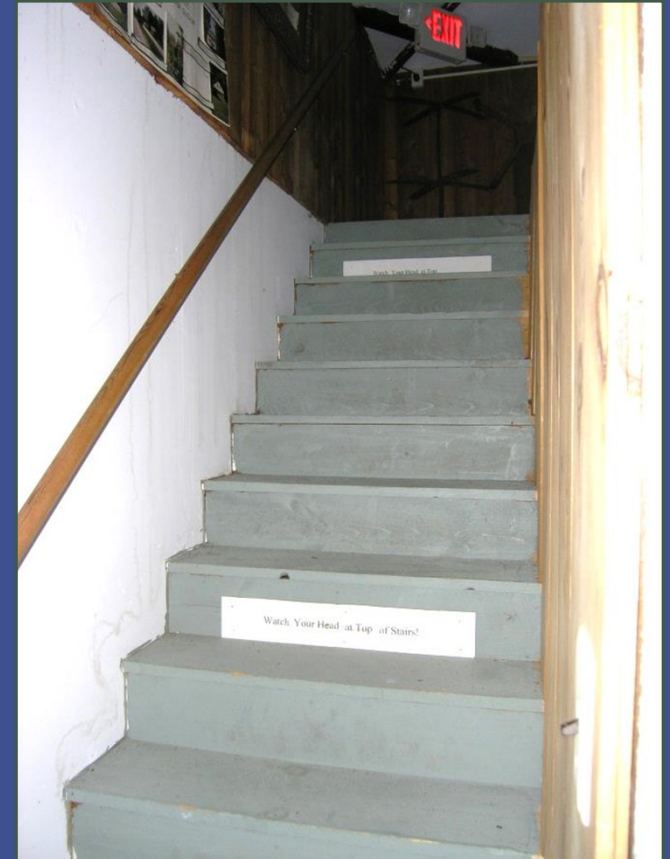
Code Compliance Issues – Historical Society

- ADA Building Accessibility
 - Does not meet 60% accessible entrances
 - Door hardware non-accessible
 - Does not provide Automatic Door Opener
- No ADA Compliant Access to Second Floor Exhibits
- No Plumbing Facilities

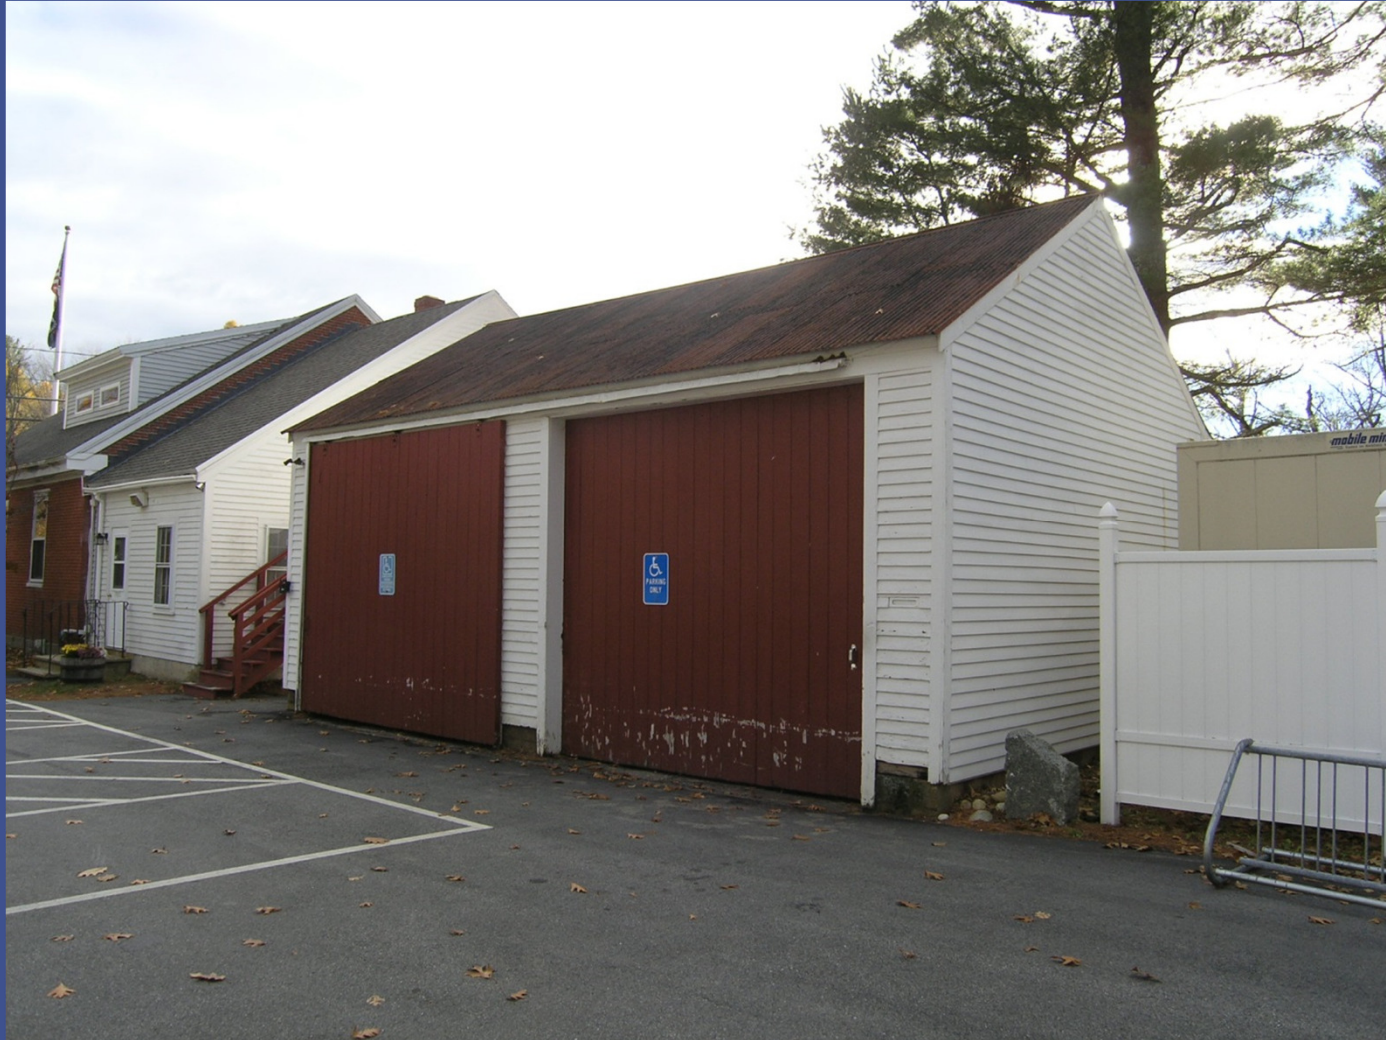
Building Evaluations – Tool Shed with Tramp Room

- ❑ Corrugated Metal Roof is Very Rusty
- ❑ Roof Framing Is Very Light
 - Only two timber ties to prevent spreading
- ❑ No Mechanical or Plumbing
- ❑ Electrical New MC Cable from Town Hall

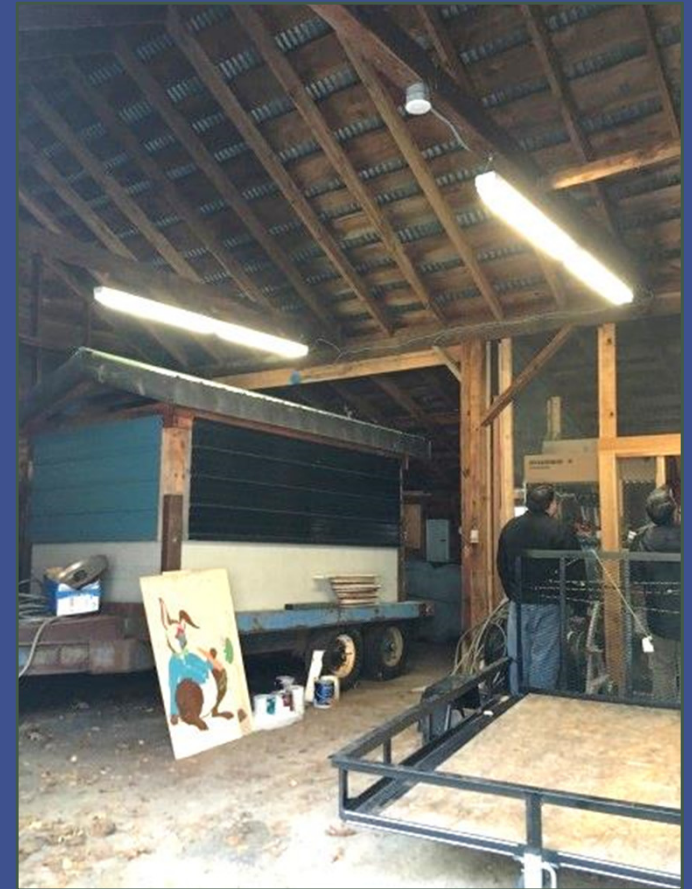
Lack of Adequate Space – Tool Shed with Tramp Room

- Currently Used for Storage

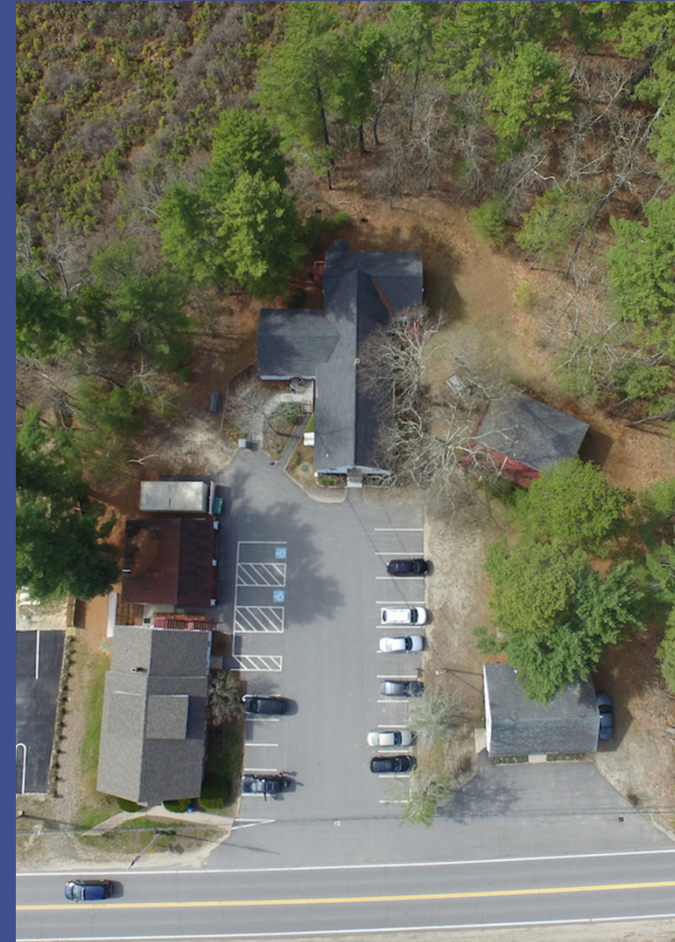
1. Town Hall Site Expand/Renovate Town Hall and Library

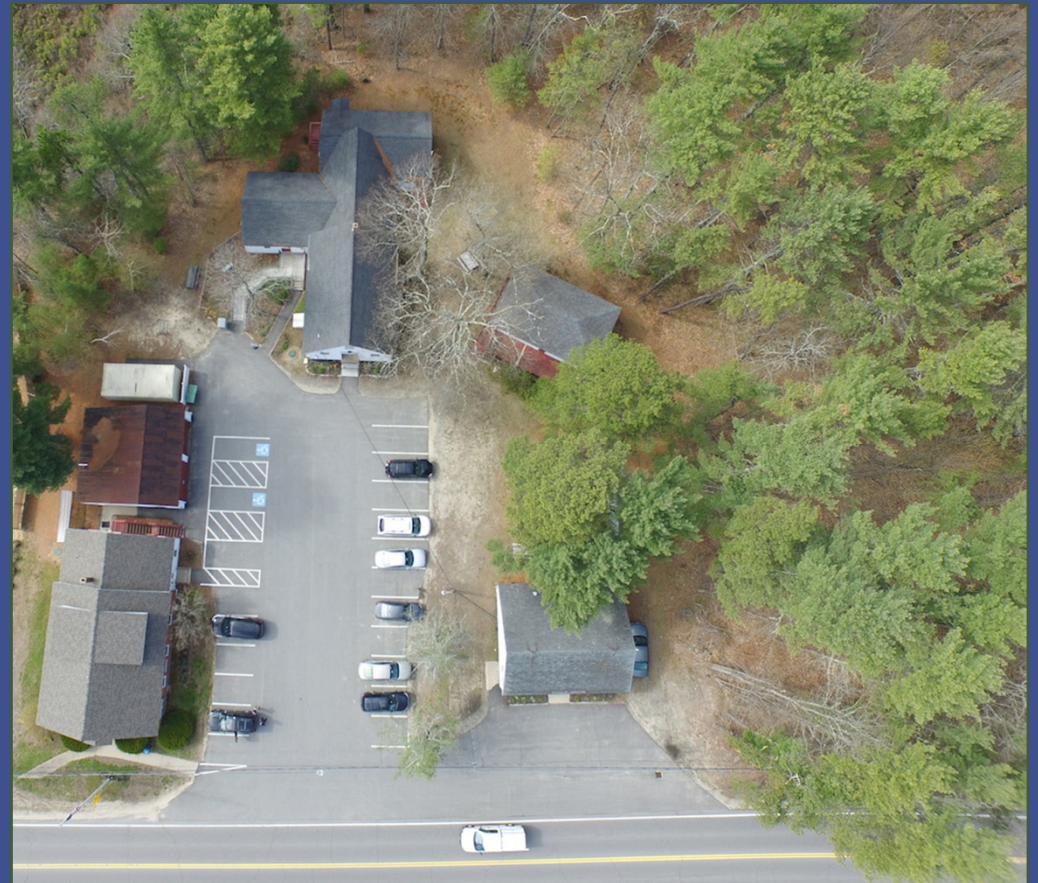
2. Town Hall Site with Church Property Expand/Renovate

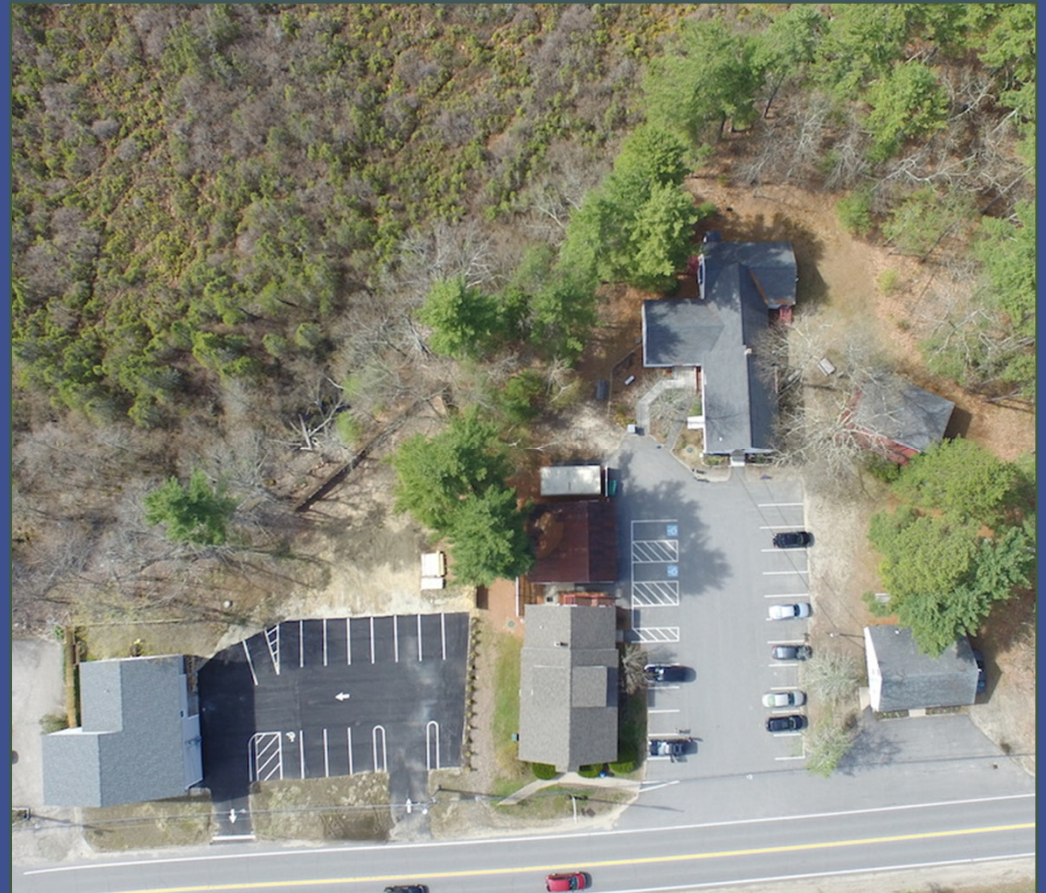
3. Town Hall Site with Banister Property Expand/Renovate

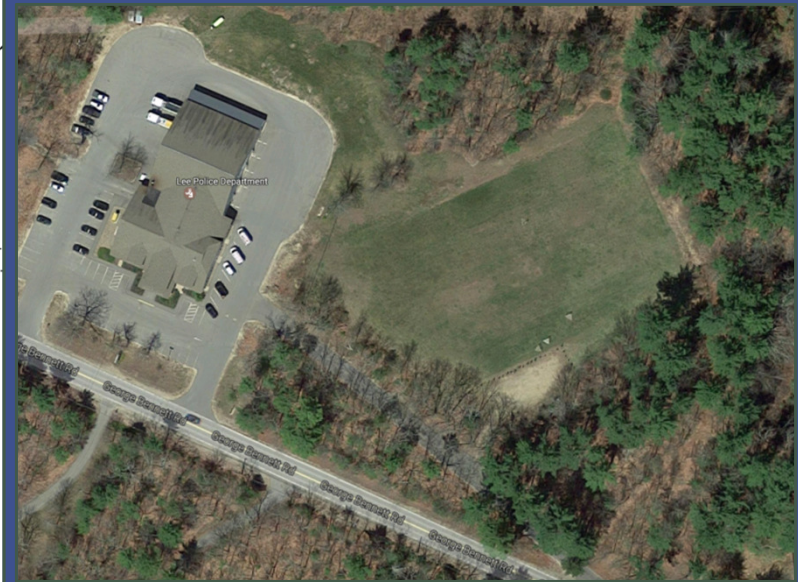
5. Stevens Field Site for Town Hall, Library at Current Site
